Case Study

Advanced Power Quality Analyzer diagnoses - the reason for cable overheating and power transformer failure

Espec's advanced portable power quality analyzer, the G4500, identified the root cause of cable overheating and transformer failure in a major hospital in the MENA region.

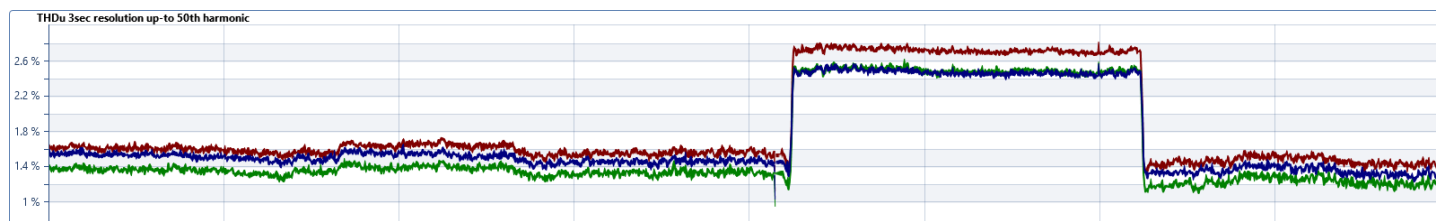
Figure 1: voltage THDu at 3-sec resolution with harmonics up to the 50th

Figure 1 (above) illustrates the voltage THDu up to the 50th harmonics at 3-second resolution as per IEEE 519 standards require. It can be observed that when the filters are switched off, the THDu level increases from 1.6% to 2.8%, as expected.

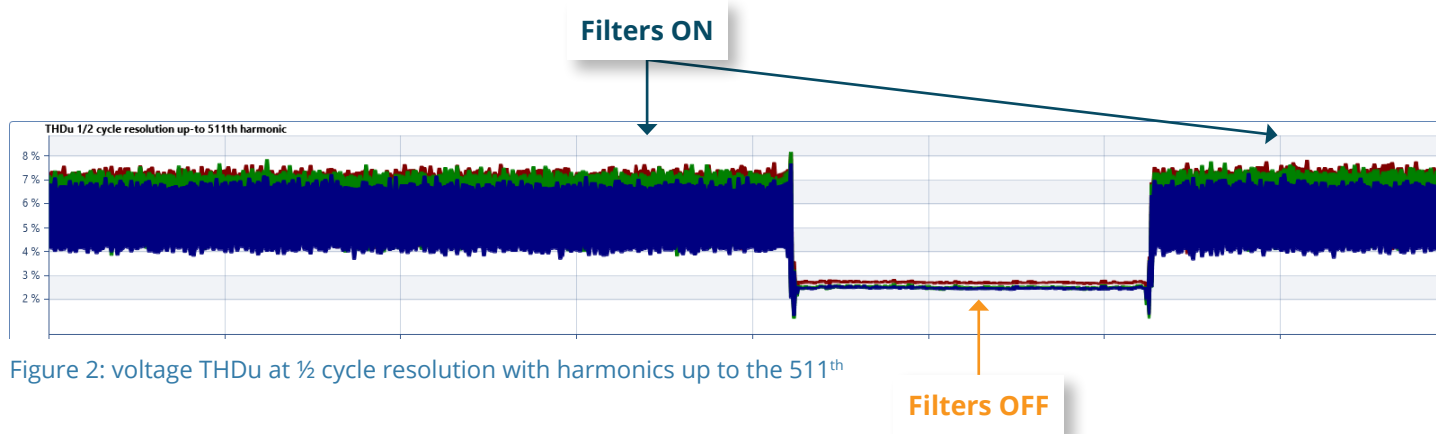
Figure 2: voltage THDu at 1/2 cycle resolution with harmonics up to the 511th

However, looking at the voltage THDu at 1/2 cycle resolution up to the 511th harmonic (Figure 2 above) reveals a different picture. When the filters are switched off, the THDu level decreases to 2.5% from 7.5%, the THDu level apparent when the filters were operated. That meant that the switching operation of the active filters contributed approximately 70% of the total THDu. This is the opposite of what was expected.

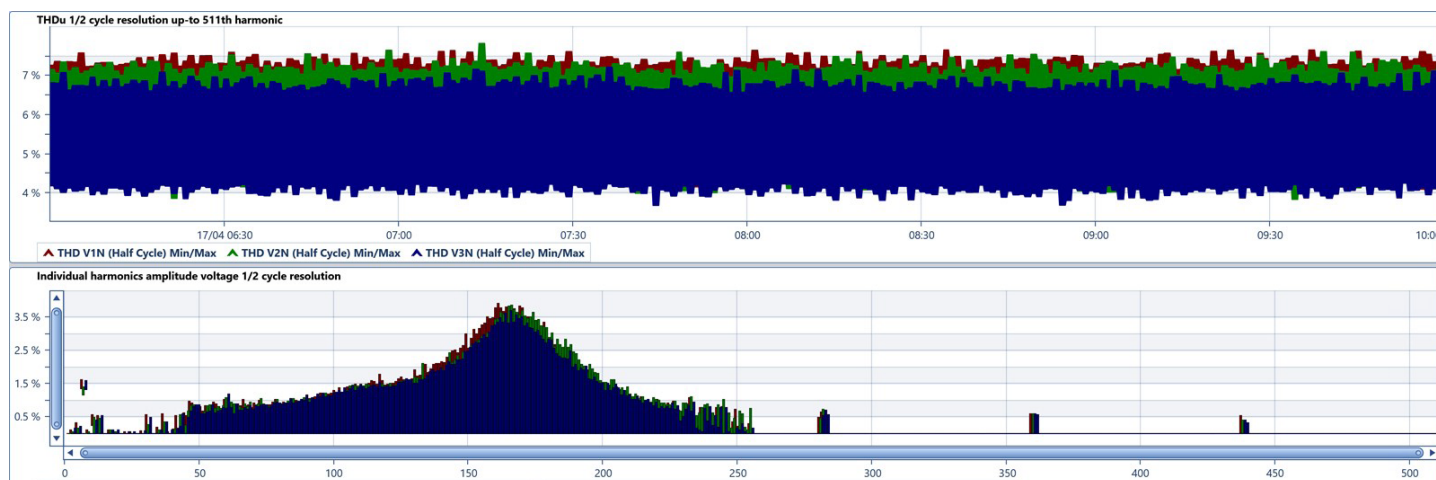
Figure 3: voltage THDu and individual harmonic spectrum at 1/2 cycle resolution while filters are switched on

Figure 3 (above) indicates an unexpected, significant harmonic activity in the range of 2.5–12.5kHz when the filters are operating. However, while filters are switched off (figure 4) below, the high frequency harmonics are barely discernable or not present at all.

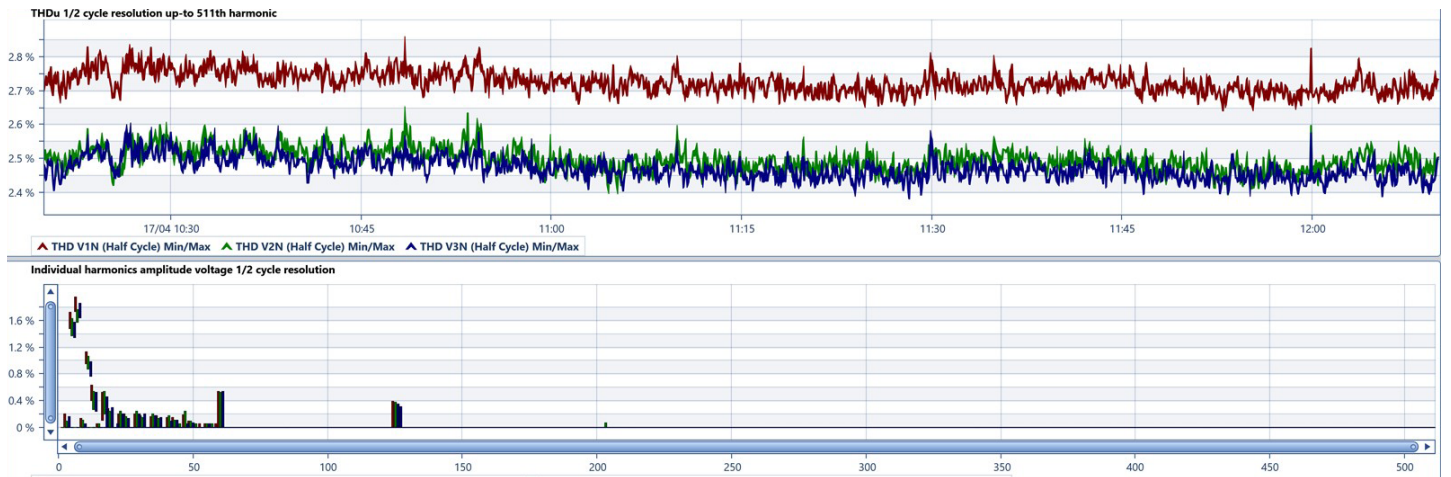
Figure 4: voltage THDu and individual harmonic spectrum at $\frac{1}{2}$ cycle resolution while filters are switched off

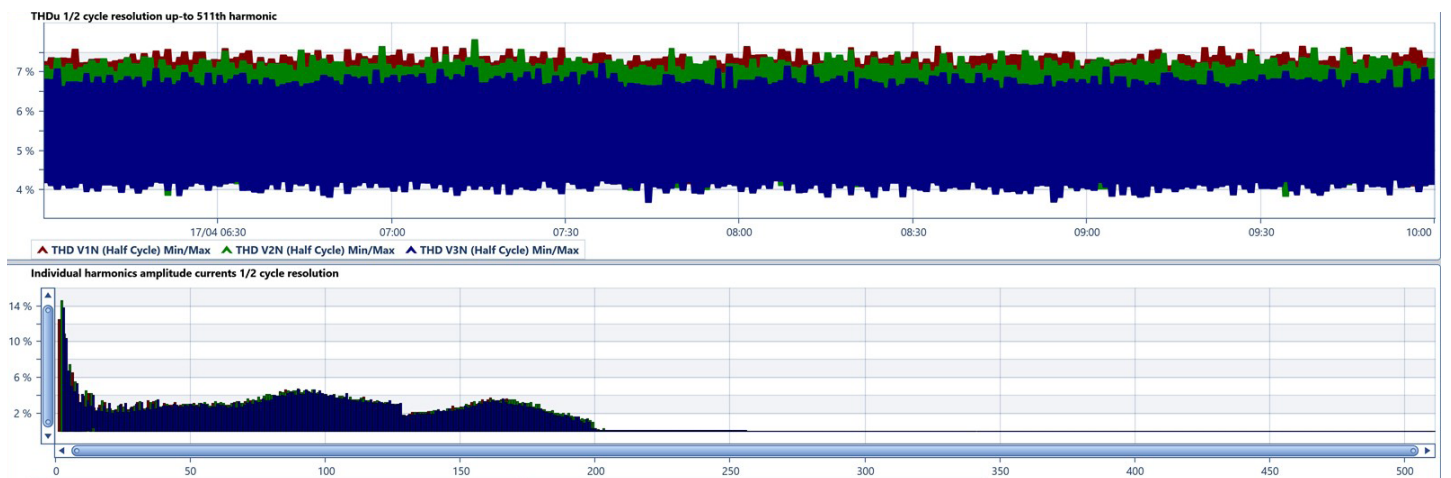
Furthermore, high frequency harmonic currents were also produced during the operation of the active filters, as can be observed in Figure 5 below:

Figure 5: voltage THDu and individual current harmonic spectrum at $\frac{1}{2}$ cycle resolution while filters are on

The currents above the 127th order, as shown in Figure 5, were similar to those found in induction heating systems. These high frequency currents, when combined with the resultant additional losses and heating effects, were a direct or contributory factor in the recent failure of the 2000kVA transformer and the overheating of cables and switchboard.
