## Case Study

# Identifying the Cause of Laser Cutting Interruptions in Automotive Manufacturing with Power Quality Analysis

Elspec's power quality analyzers identified the root cause of laser cutting machine interruptions in automotive manufacturing in Macedonia, enabling a targeted solution that enhanced operational stability.

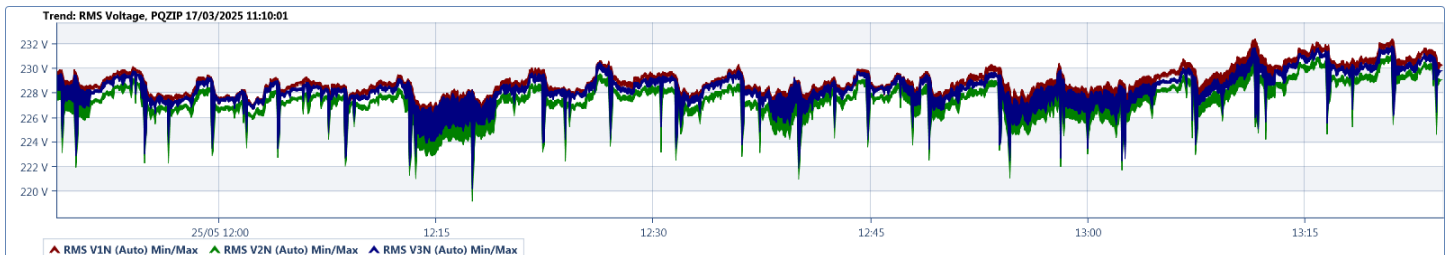
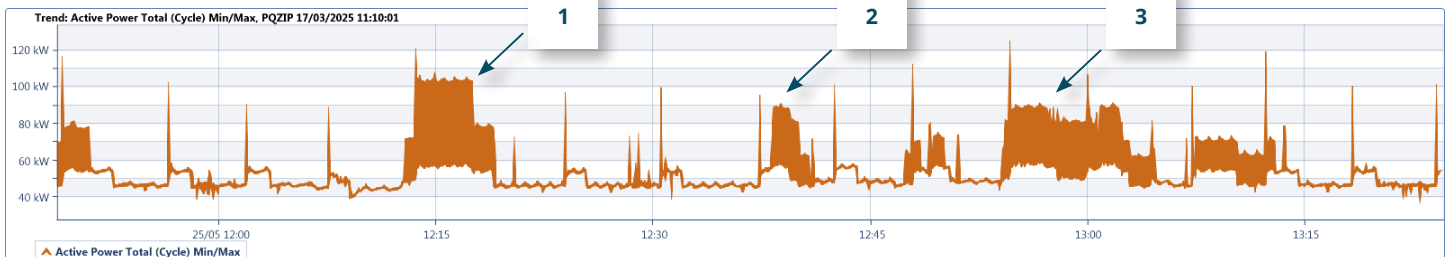
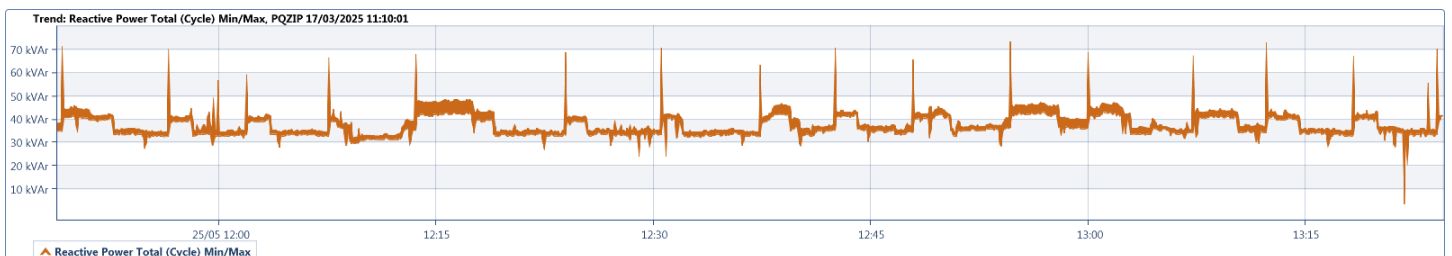
The analysis revealed 3 shutdown occasions.

The first laser shutdowns caused by Rapid Voltage Changes (RVCs). These voltage fluctuations, while staying within normal operating limits ( $\pm 10\%$  of nominal voltage, 440V), lasted for approximately 1.7 seconds and were significant enough to disrupt the laser cutting process. These changes are almost impossible to detect with a typical analyzer that relies on triggers. Such voltage variations wouldn't activate the trigger and, therefore, might go completely unnoticed.

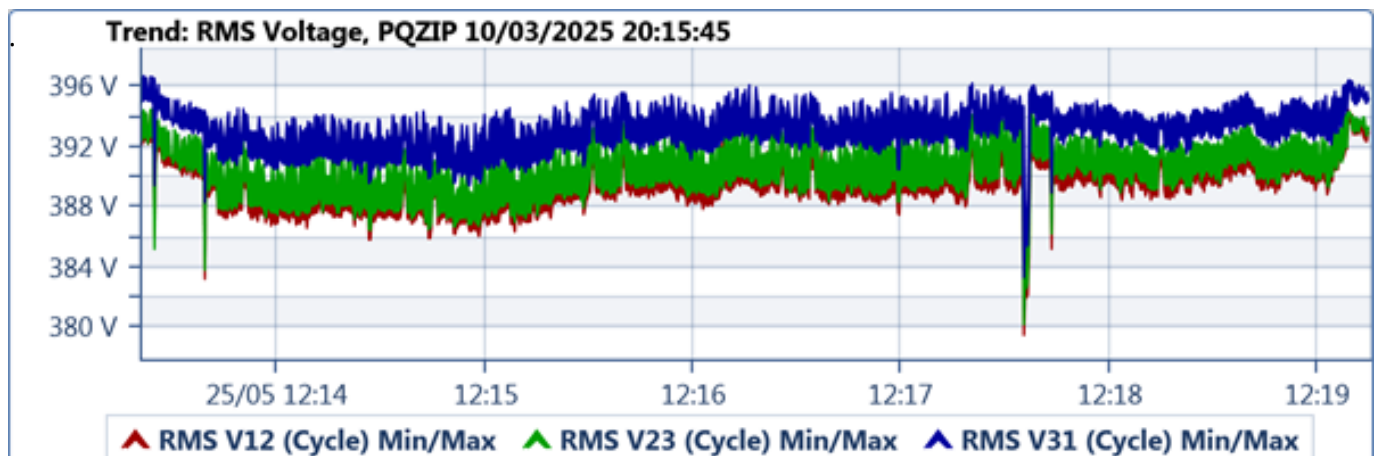
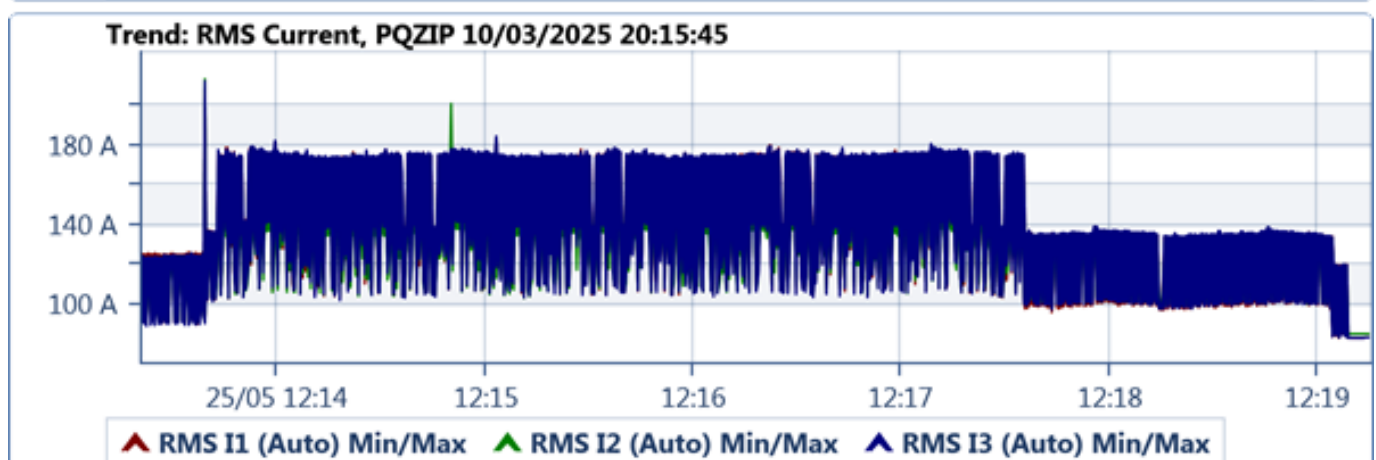
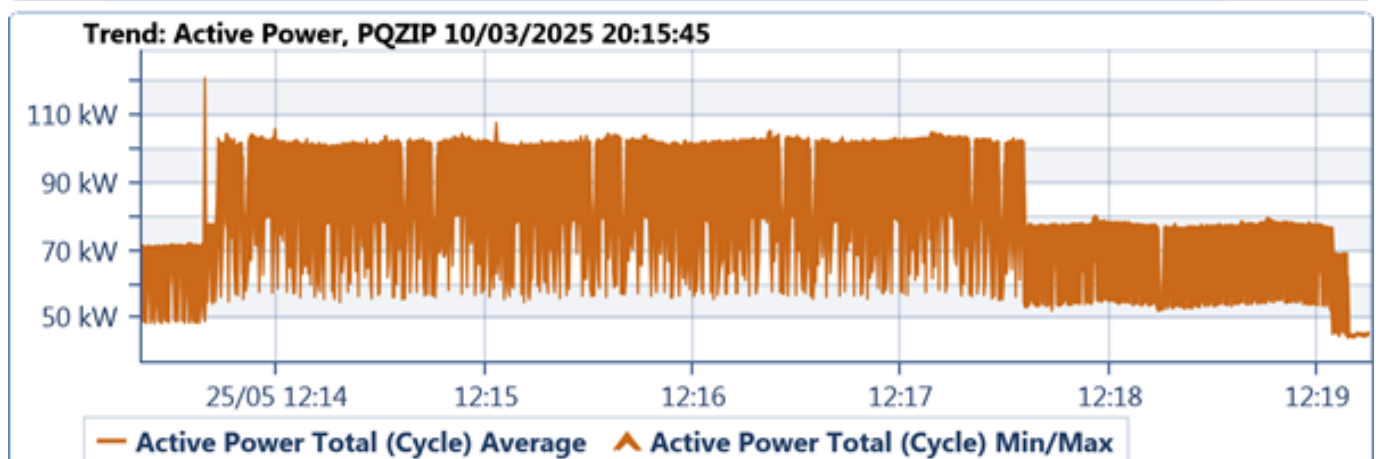
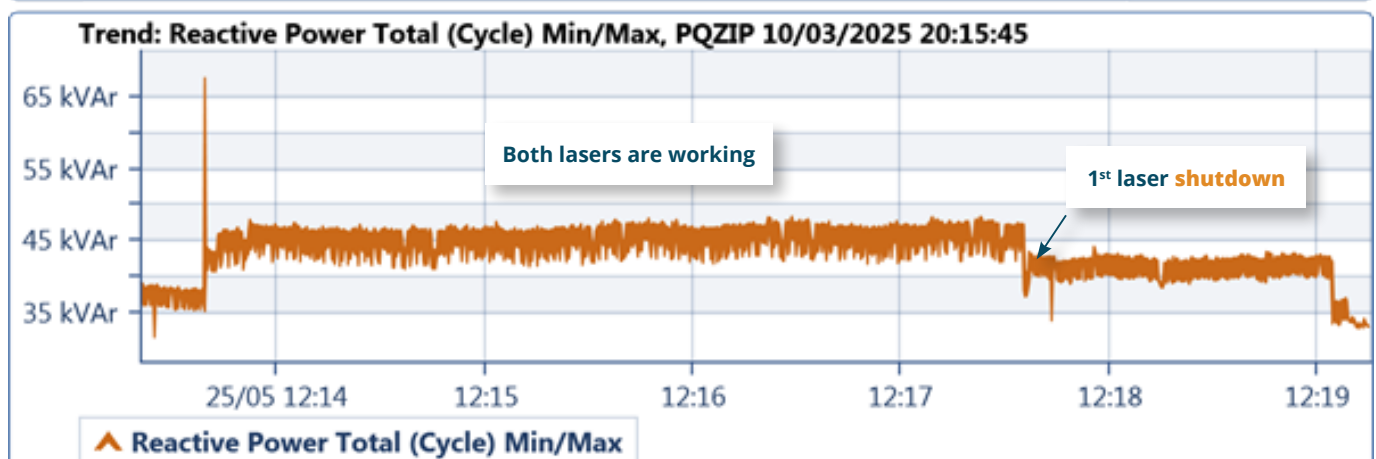
1<sup>st</sup> Laser Shutdown Correlated with Rapid Voltage Change

The graph above shows the initial startup of the laser cutting machine at 12:13h. At this time, Laser 2 turns on first, followed by Laser 1 several seconds later, in alignment with the production cycle. This delayed activation of Laser 1 is reflected in the increase in both power and current observed in the graph.

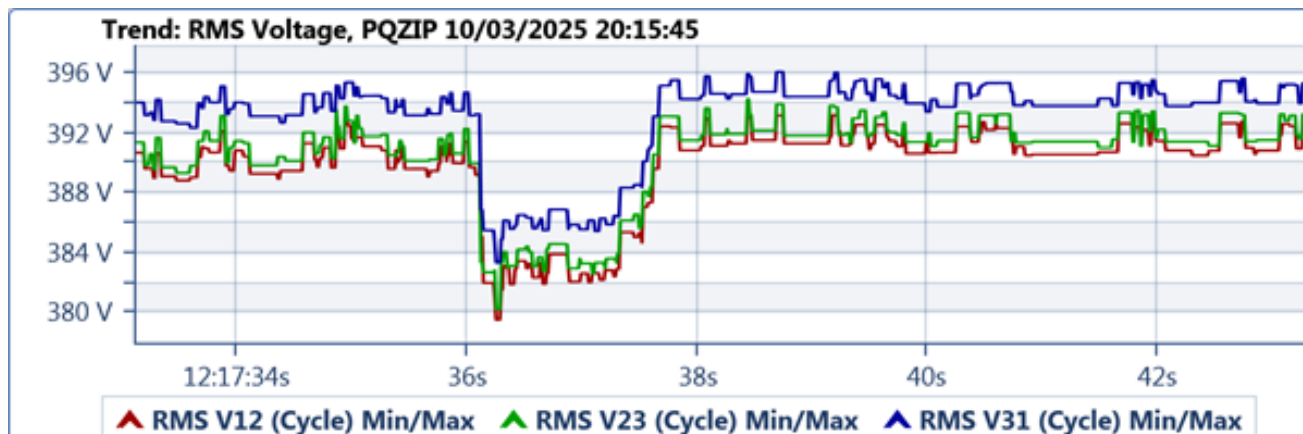
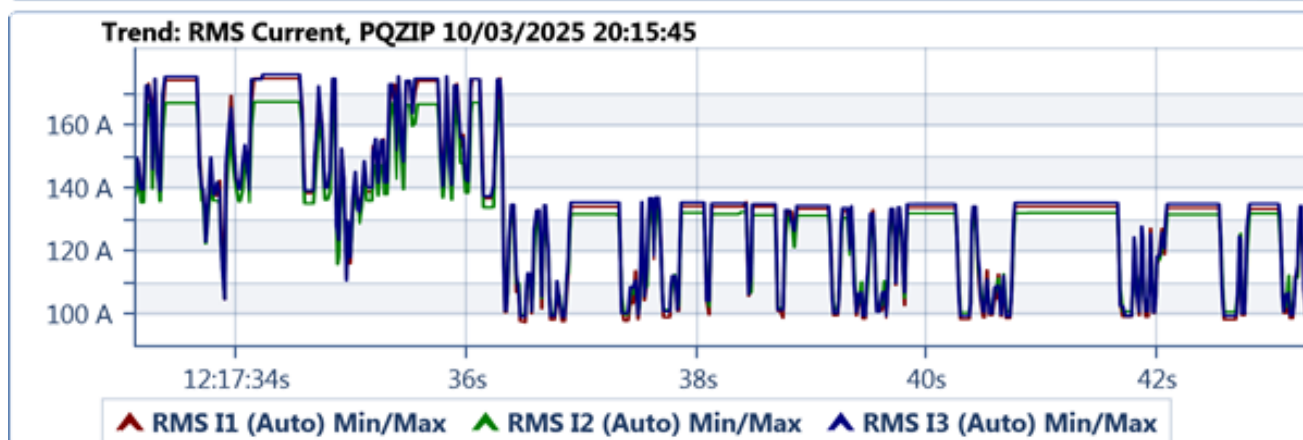
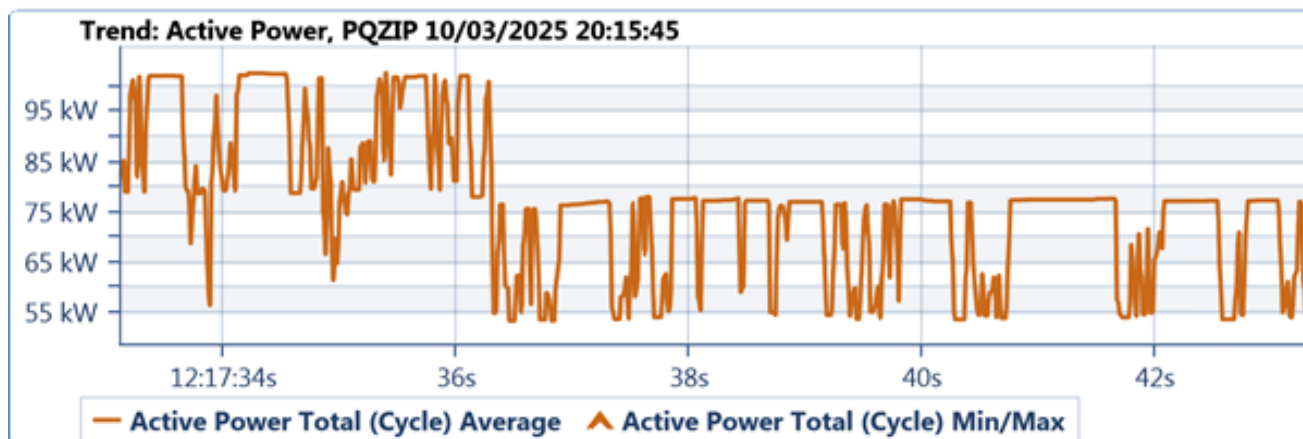
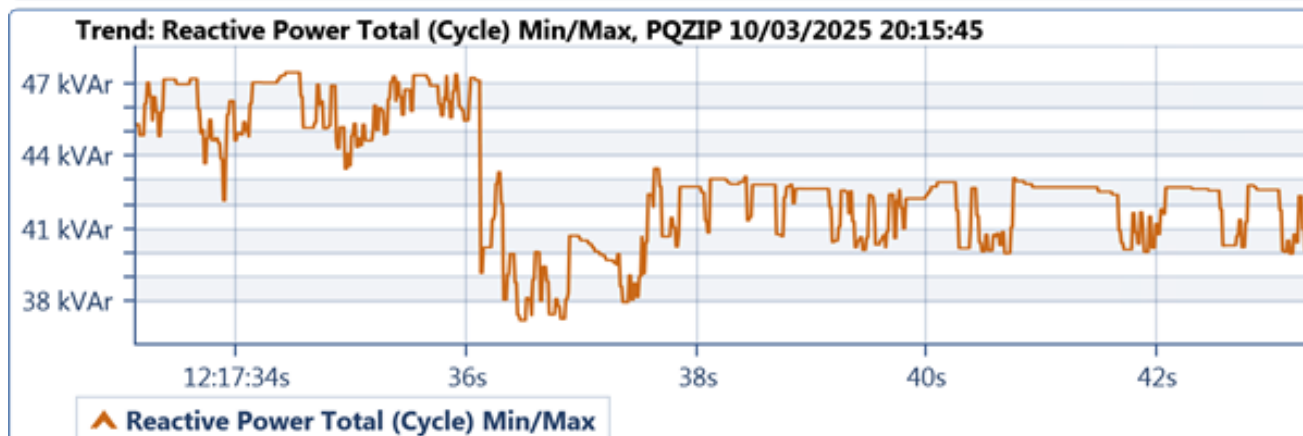
From this point onward, the laser cutting machine operates with both lasers running under normal conditions. However, between 12:17h and 12:18h, an unwanted shutdown of Laser 1 occurs, as shown by the marked decrease in current and power on the graphs below.

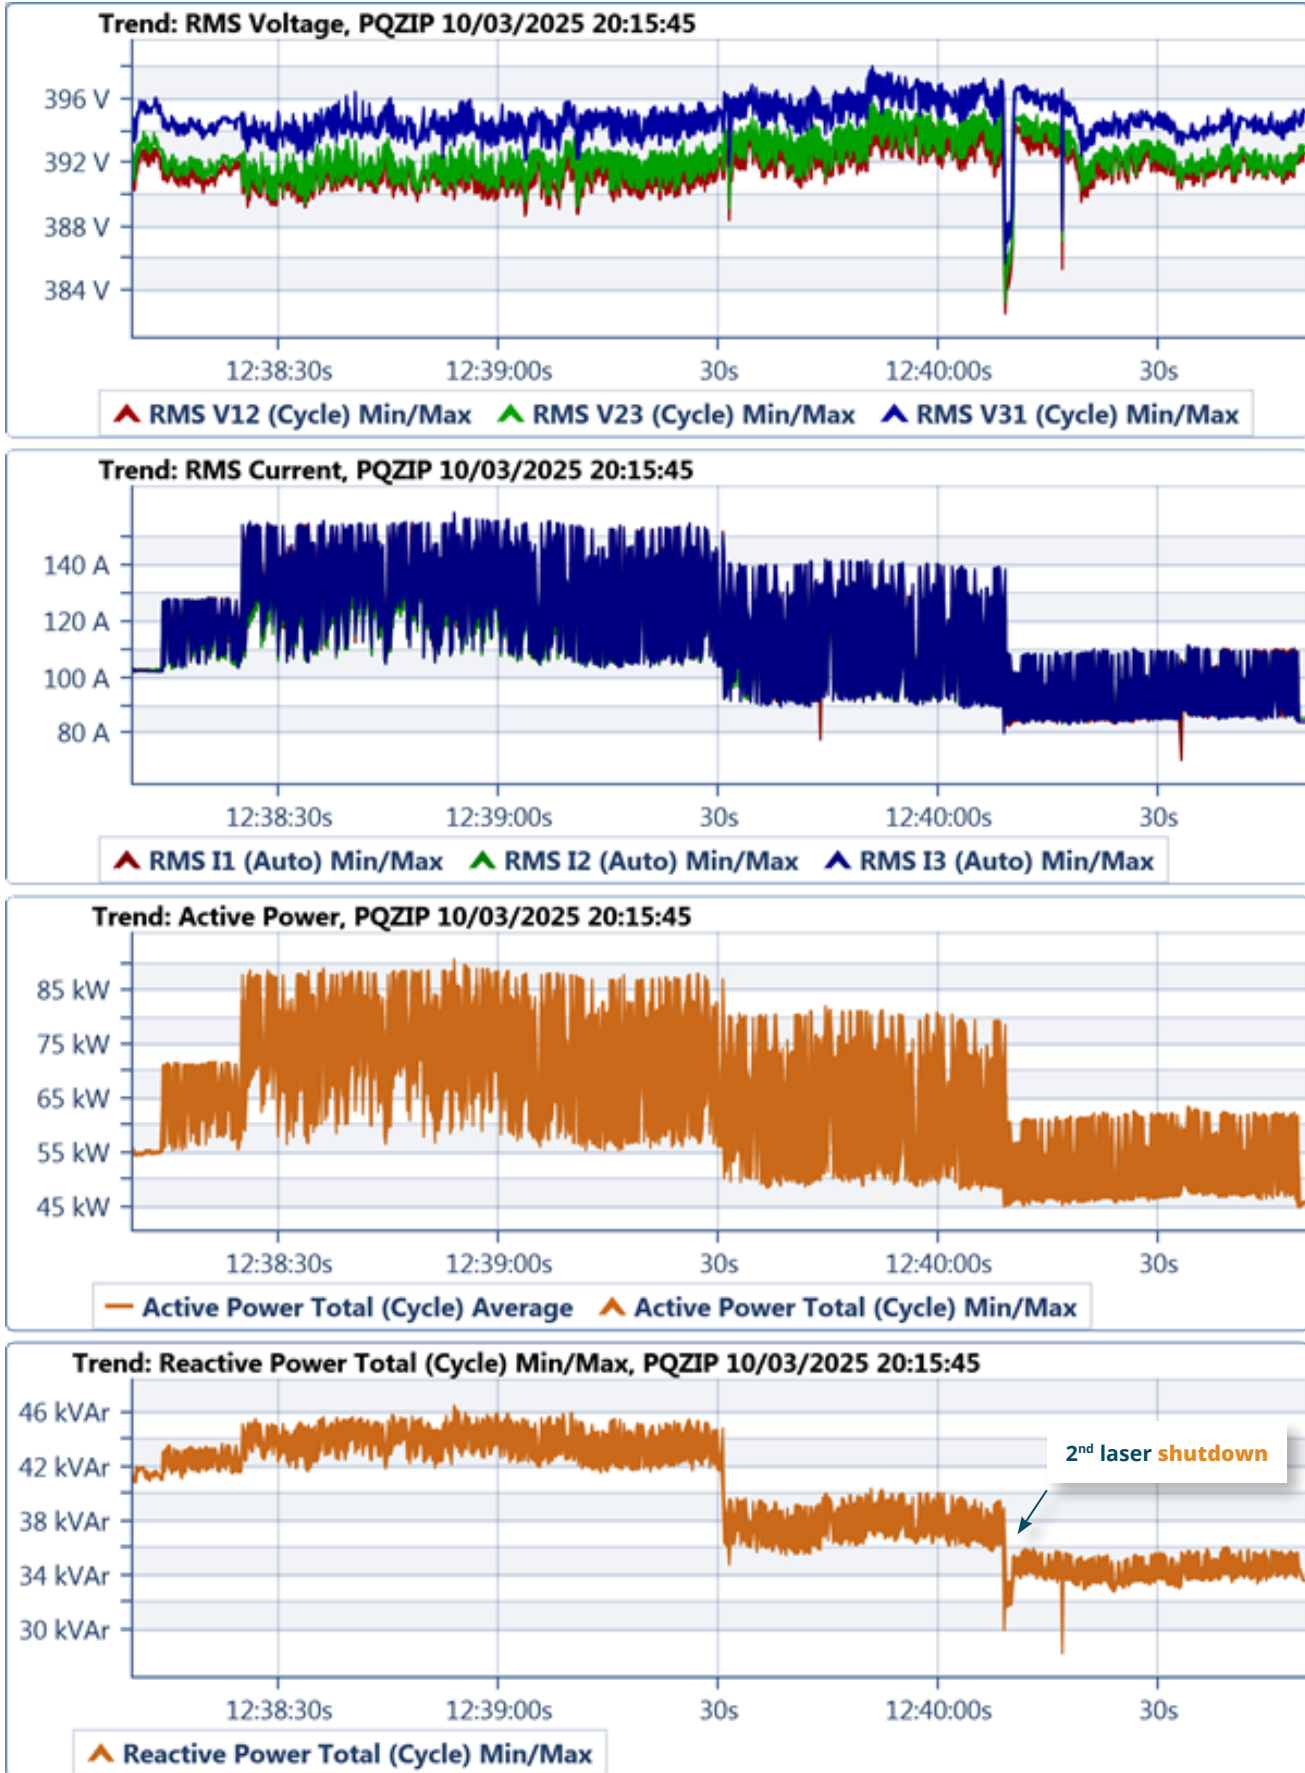
2<sup>nd</sup> Laser Shutdown Correlated with Rapid Voltage Change

The second laser shutdown was observed at 12:48h.

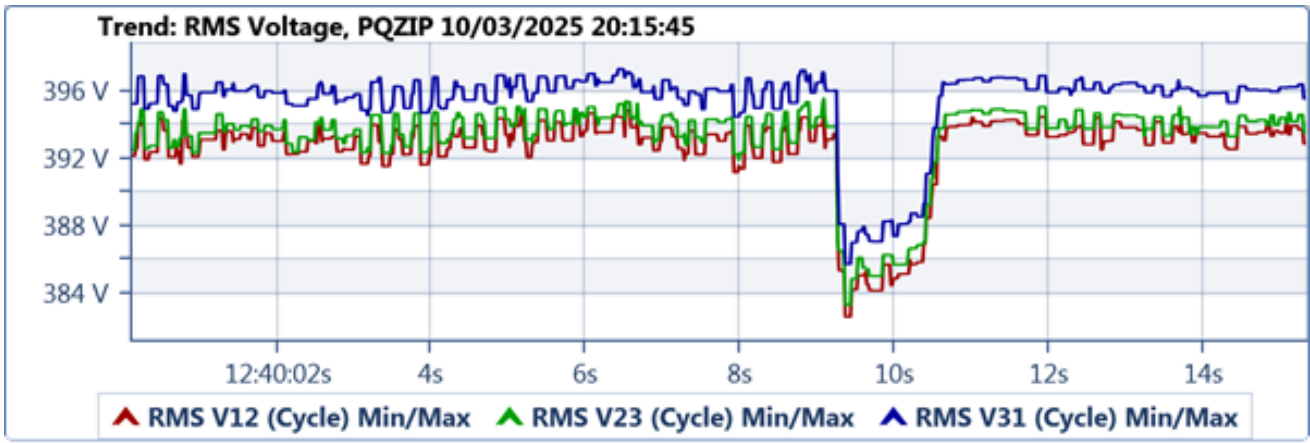
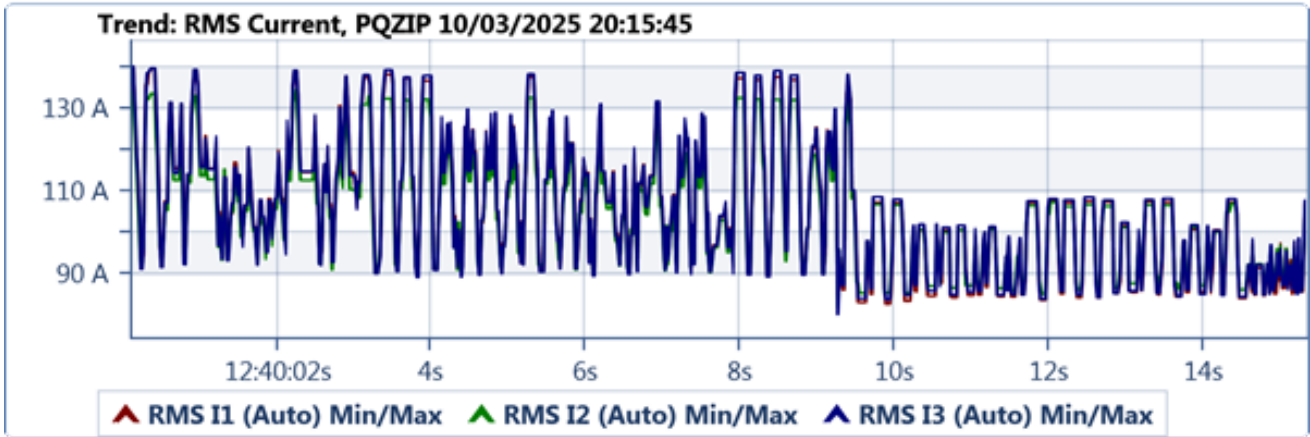
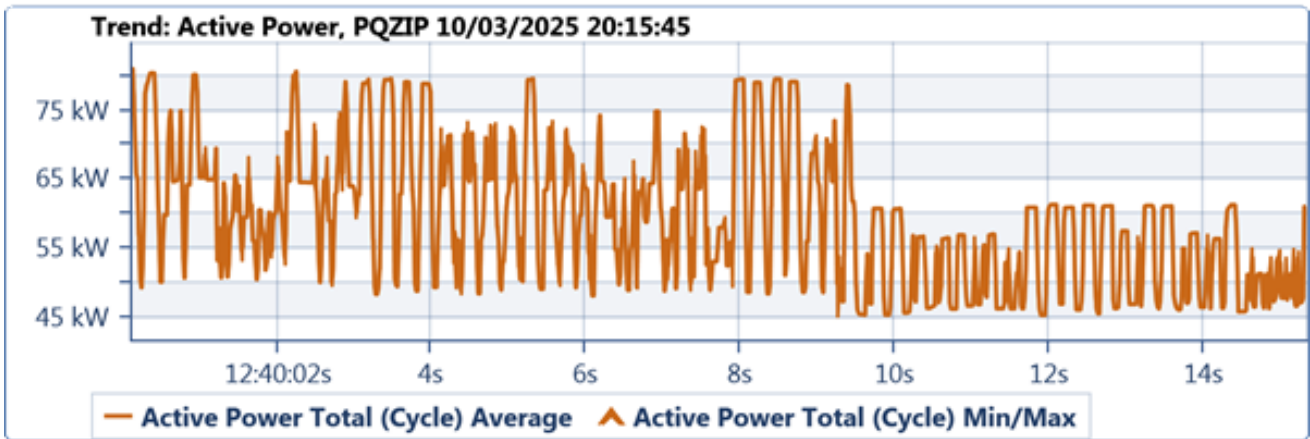
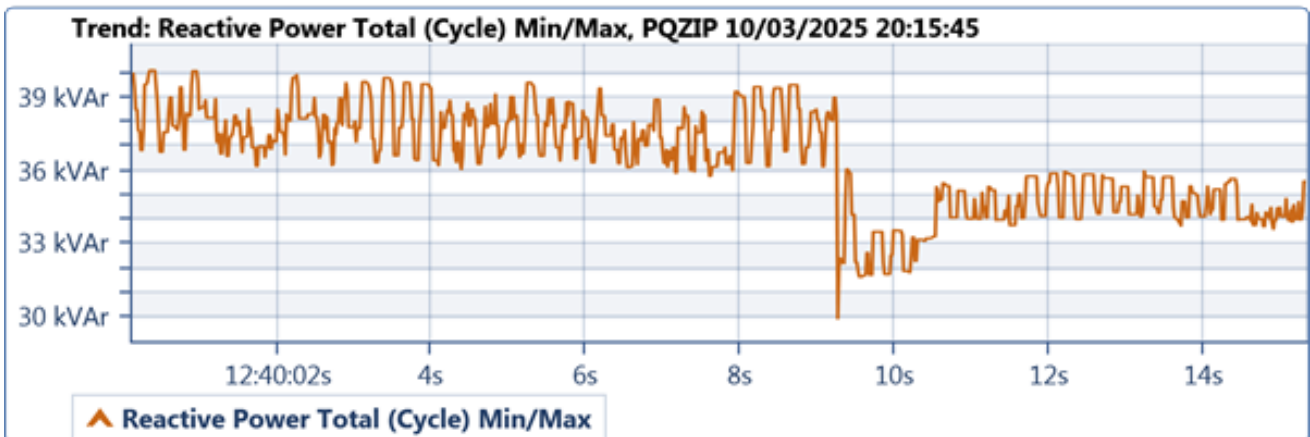
2<sup>nd</sup> Shutdown Zoom-in

Similar to the first case, this shutdown is also preceded by a Rapid Voltage Change (RVC). The graph shows the voltage drop of 7-8V along with the corresponding decrease in current. This drop in voltage, although within the acceptable range, causes a temporary disruption to the cutting process.

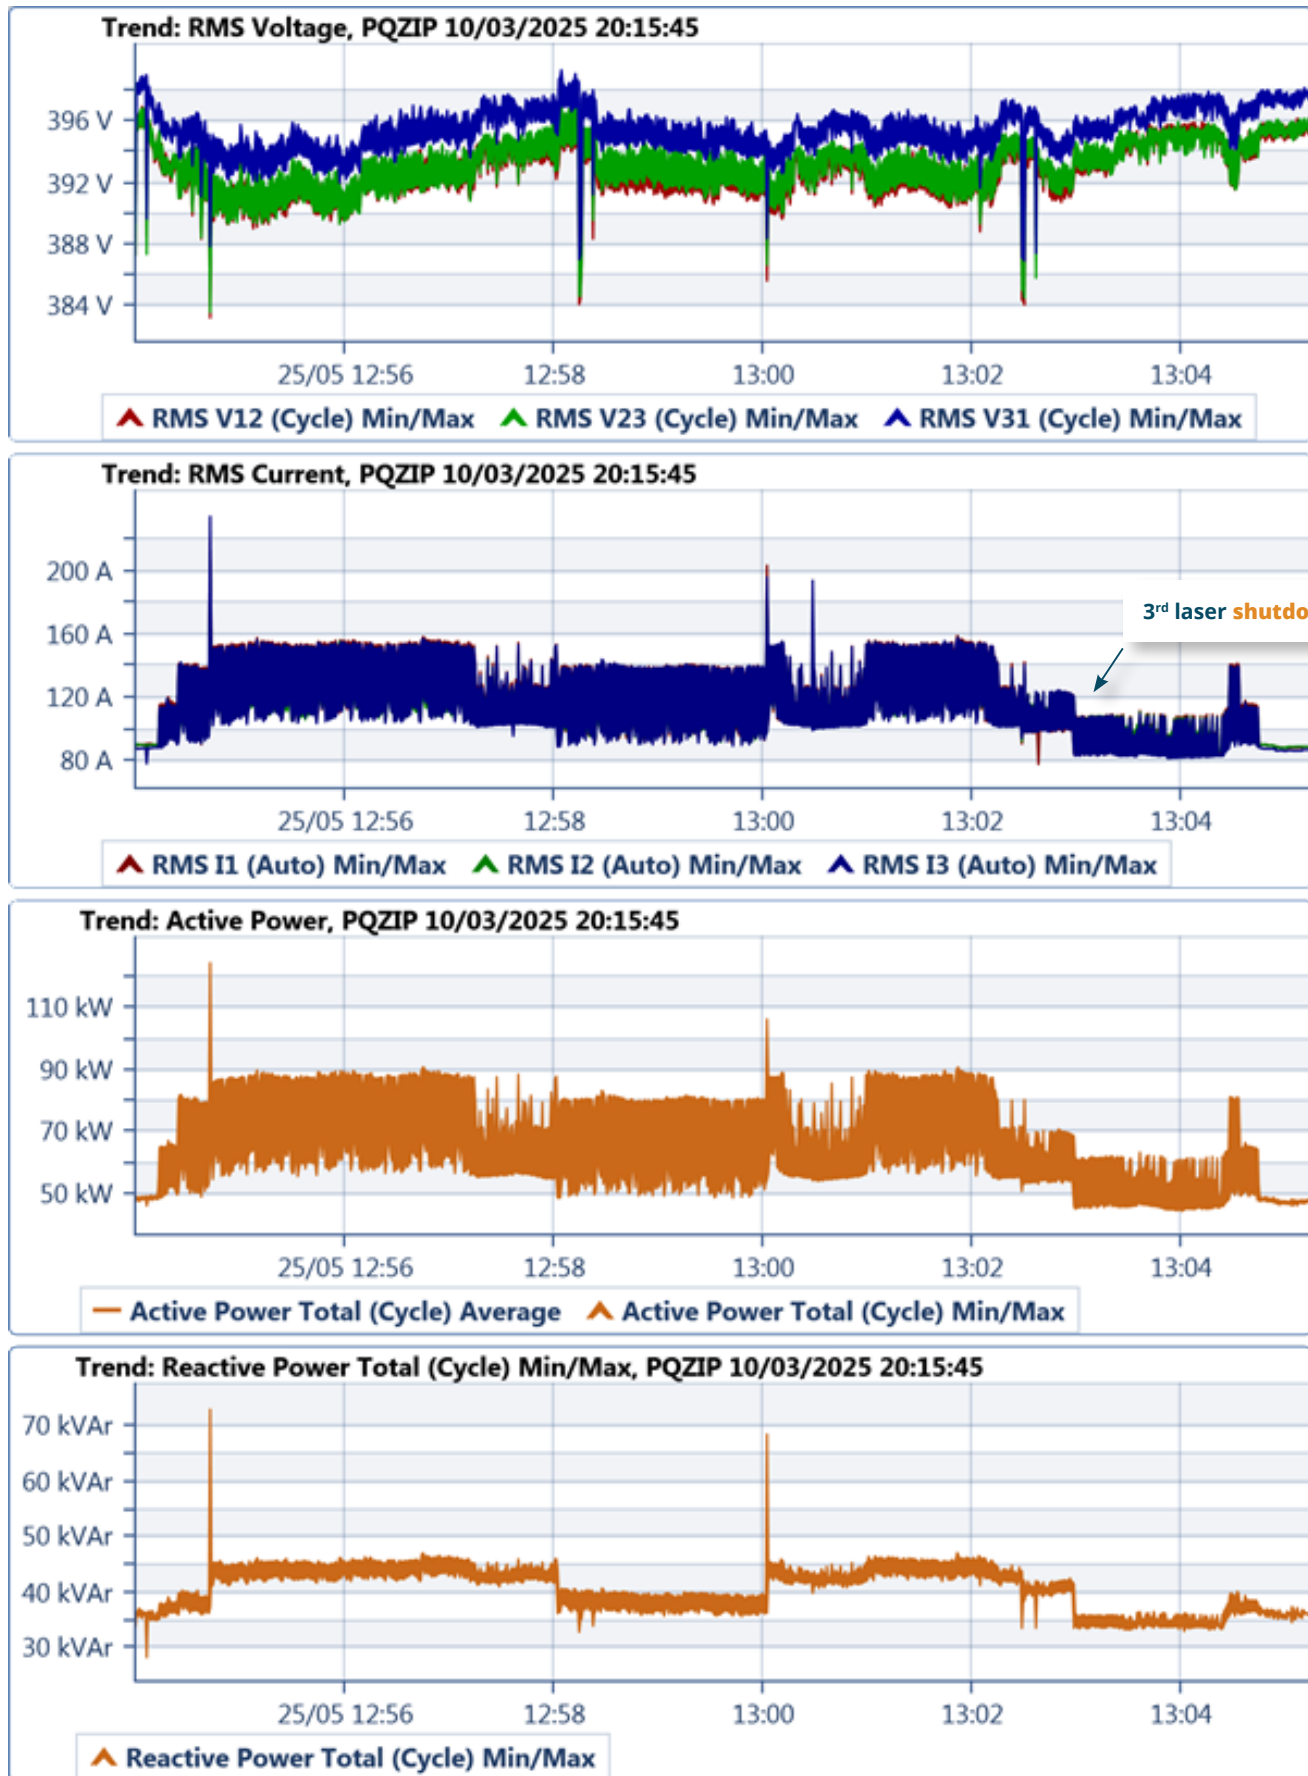
3<sup>rd</sup> Laser Shutdown

The third case shows a different scenario where the second laser turns off during a period of slow cutting.

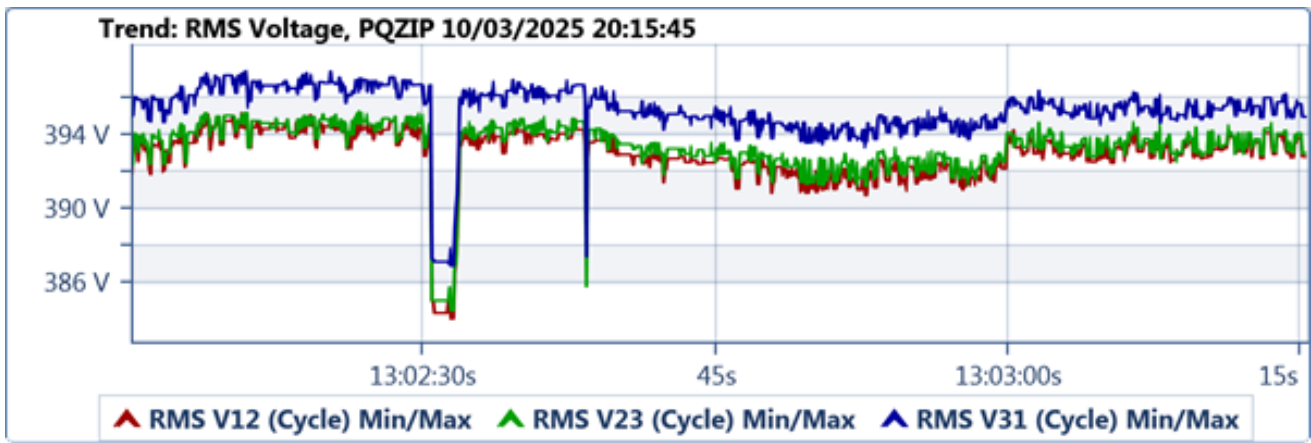
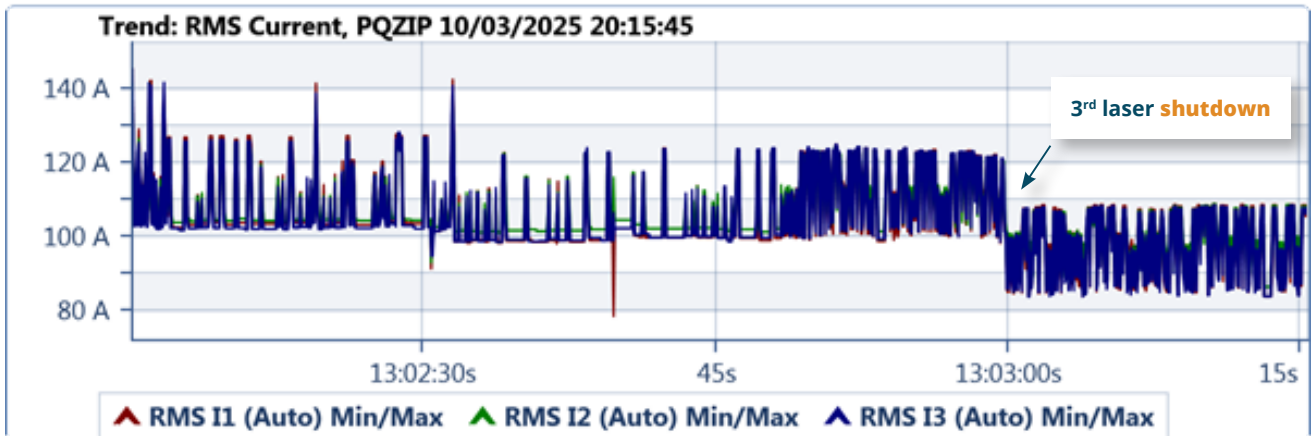
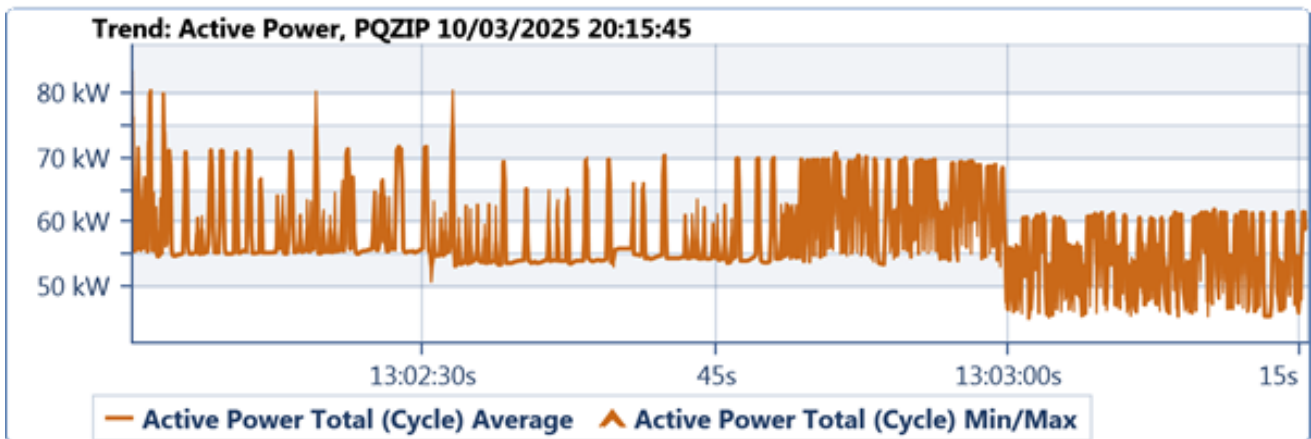
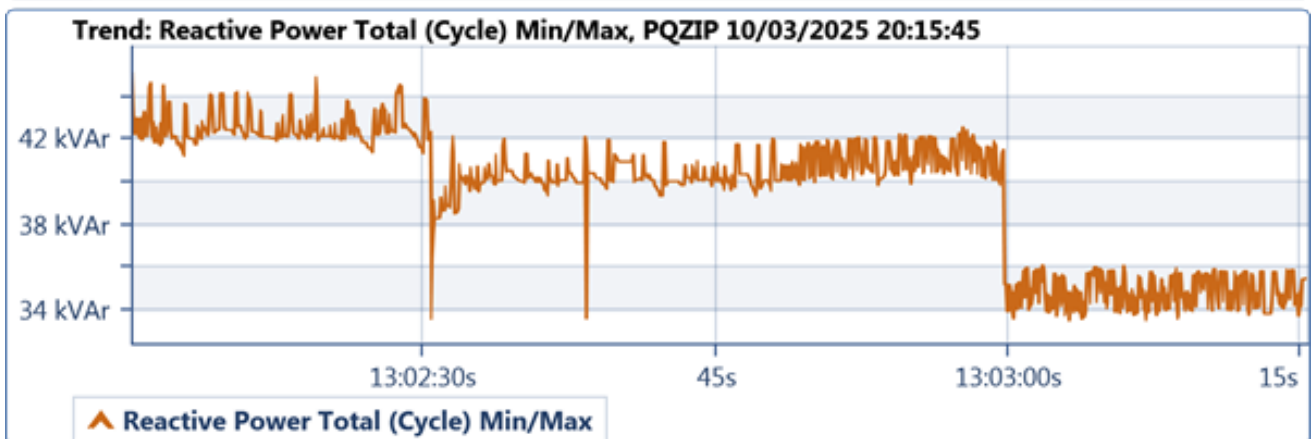
3<sup>rd</sup> Laser Shutdown

Unlike the previous two shutdowns, there is no voltage event at this point, indicating that the shutdown is unrelated to RVCs. This suggests that other factors, such as mechanical or operational causes, could have contributed to this disruption.

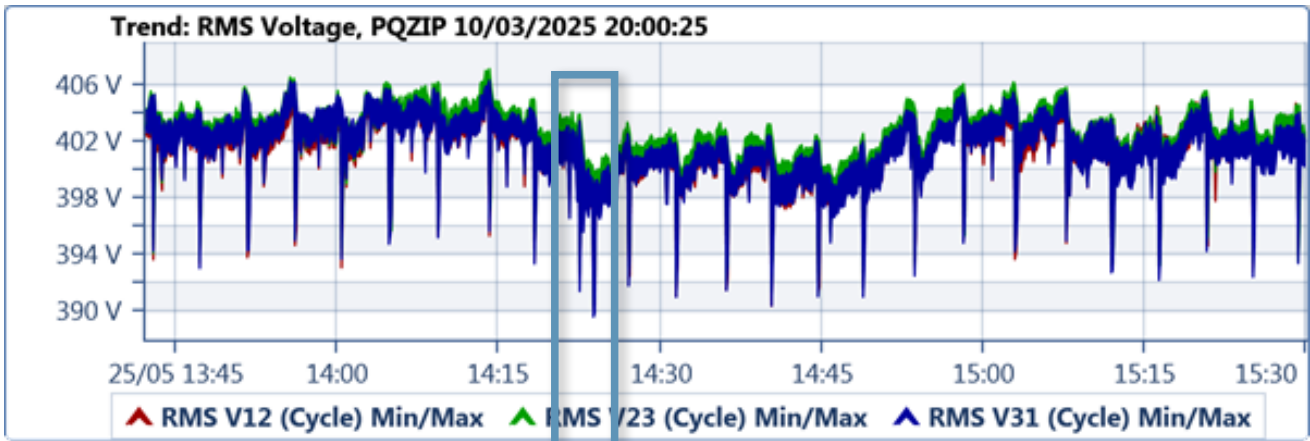
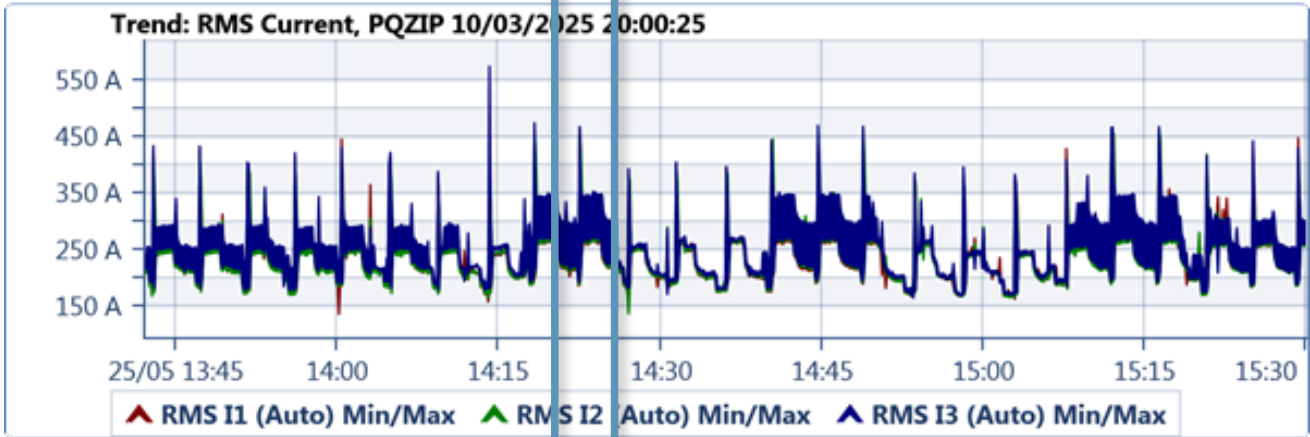
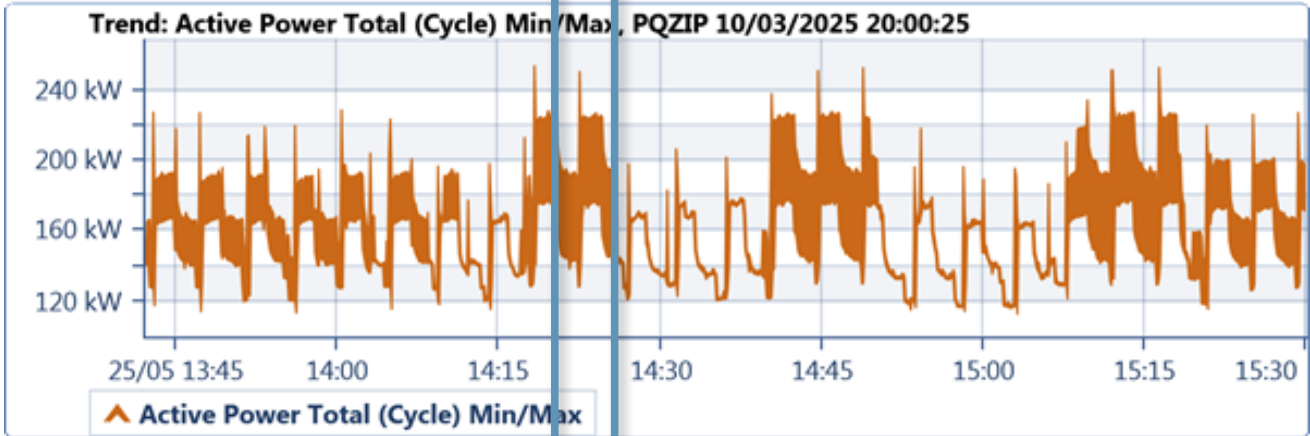
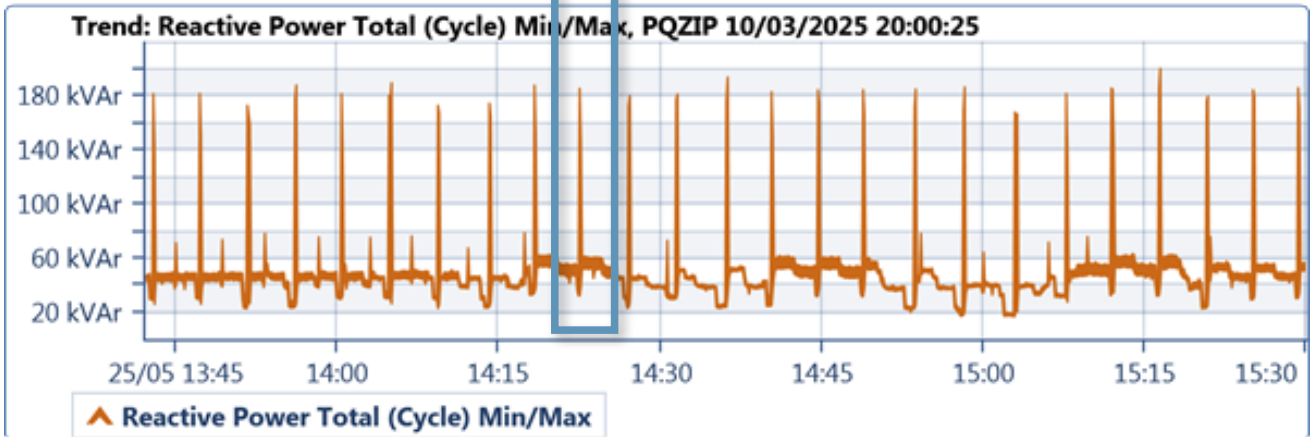
Recordings at Transformer 1 over all

Data from 2nd analyzer showed Rapid Voltage Changes (RVCs) occur approximately every 4-5 minutes. These fluctuations are likely caused by a load connected to the transformer. However, during the period of recording, the laser cutting machine continued to operate without any issues. Specifically, there were three instances where both lasers were operating simultaneously—at 14:18h, 14:40h, and 15:10h. Despite the presence of the RVCs, the machine continued its cutting cycles without any forced shutdowns.

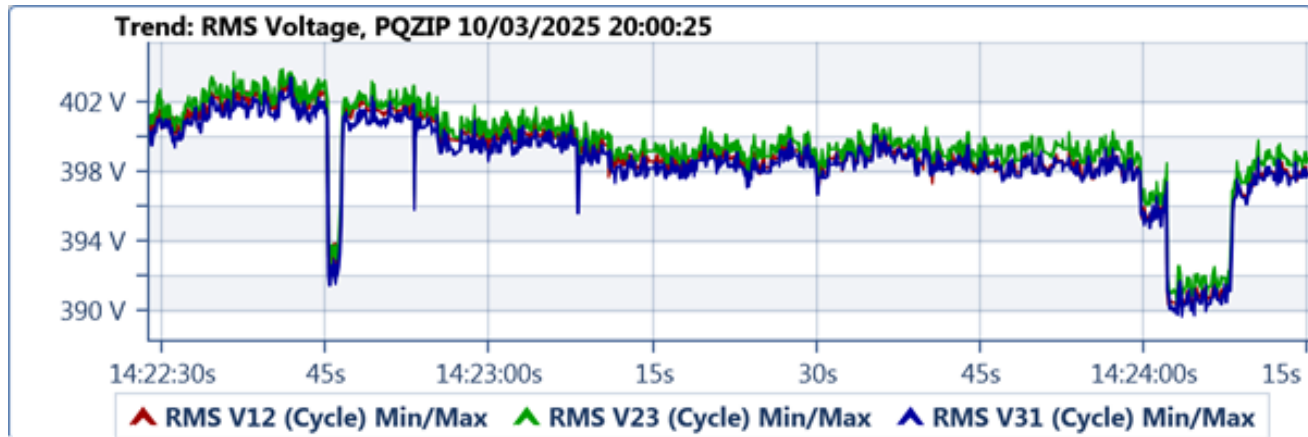
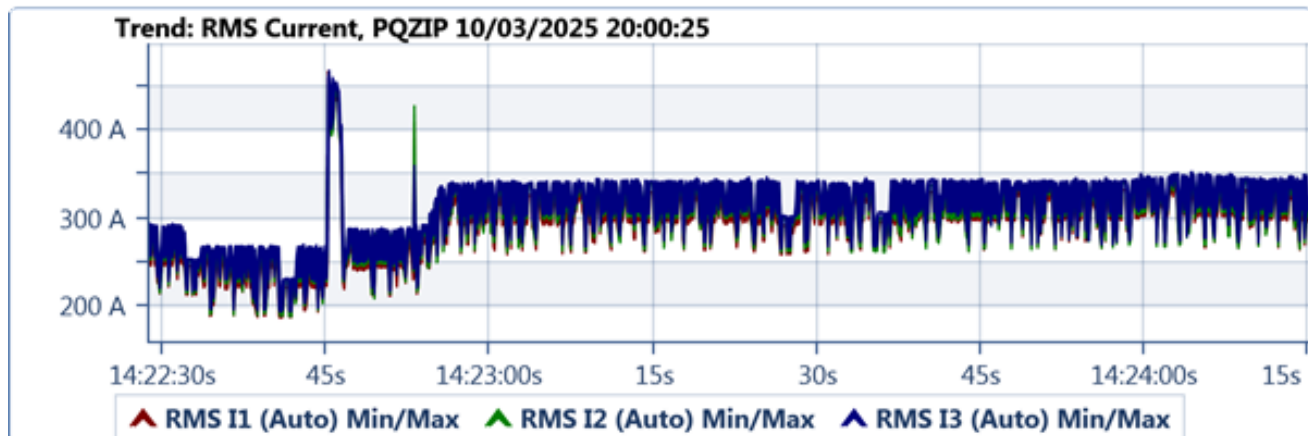
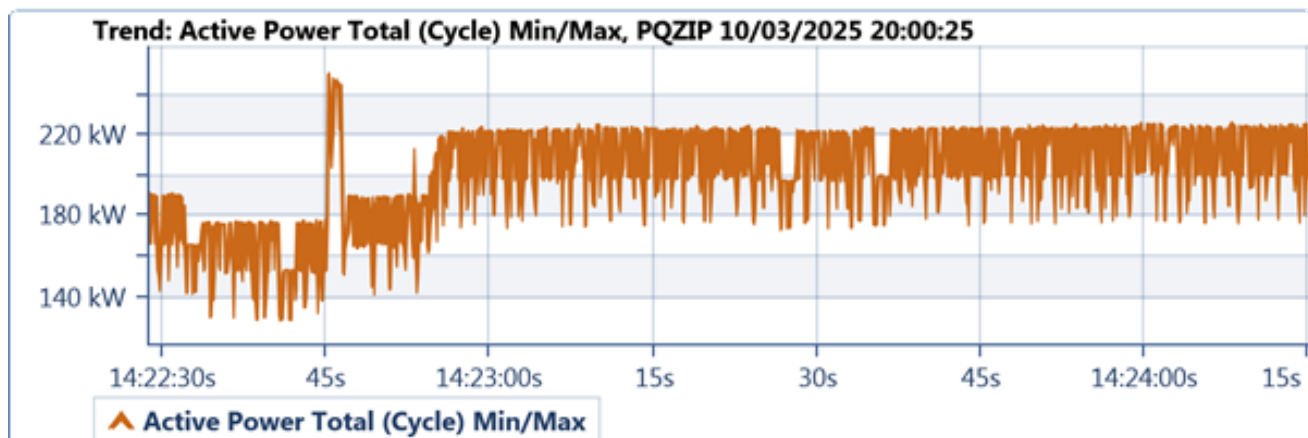
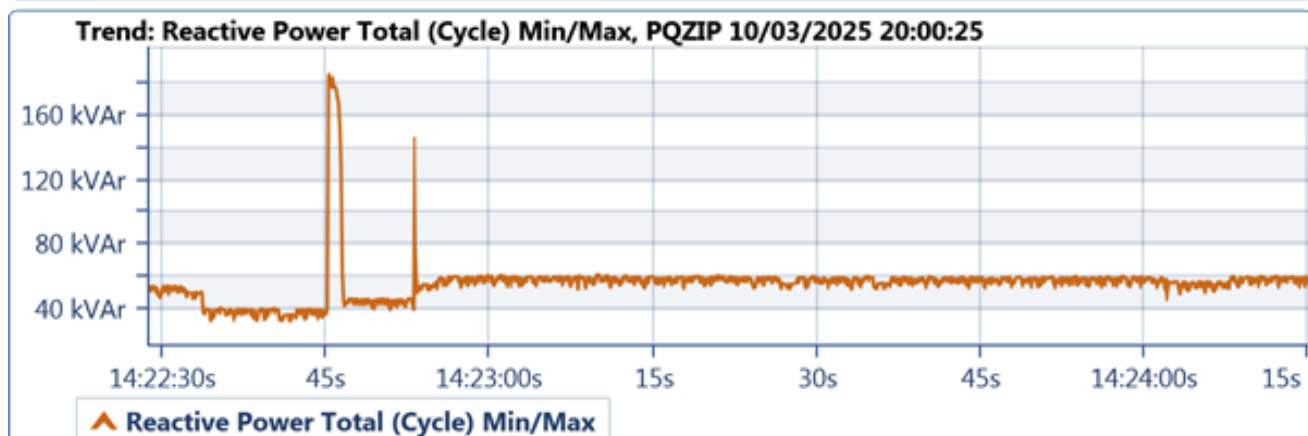
Recordings at Transformer 1 over all zoom-in

The graphs below show a zoom-in of a single RVC that occurred at 14:22:45, with a duration similar to the RVCs that were previously observed during the laser machine shutdowns. The next RVC, occurring at 14:24, was found to have originated upstream, from the higher voltage side of the system.

The RVCs occurring at regular intervals (every 4-5 minutes) were not the cause of the laser machine's shutdowns, as the machine continued to operate normally during their occurrence. This suggests that while RVCs could have been a concern, they did not significantly impact the machine's performance or cause the laser to stop during those specific measurements.

Thus, the RVCs observed were unrelated to the actual shutdown events of the laser machine, and the cause of the shutdowns must lie elsewhere (e.g., the air-conditioning chiller load affecting the voltage or other operational factors). Further investigation led to the consideration that the RVCs coincided with the operation of a chiller connected to the same transformer as the laser cutting machine. These spikes could create voltage transients that interfered with the stable operation of the laser cutting machine.

Once it was established that the air-conditioning chiller's operation was triggering the RVCs, the plant made a strategic decision to move the chiller feeder to a different transformer. The plant operates with two 20/0.4, 600kVAR transformers, and by shifting the chiller's load to the other transformer, the company was able to eliminate the voltage disturbances affecting the laser cutting machine.
