POWER QUALITY ANALYSIS OF LONG TERM EVENTS USING A CONTINUOUS POWER QUALITY RECORDER

LONG TERM POST EVENT INVESTIGATION

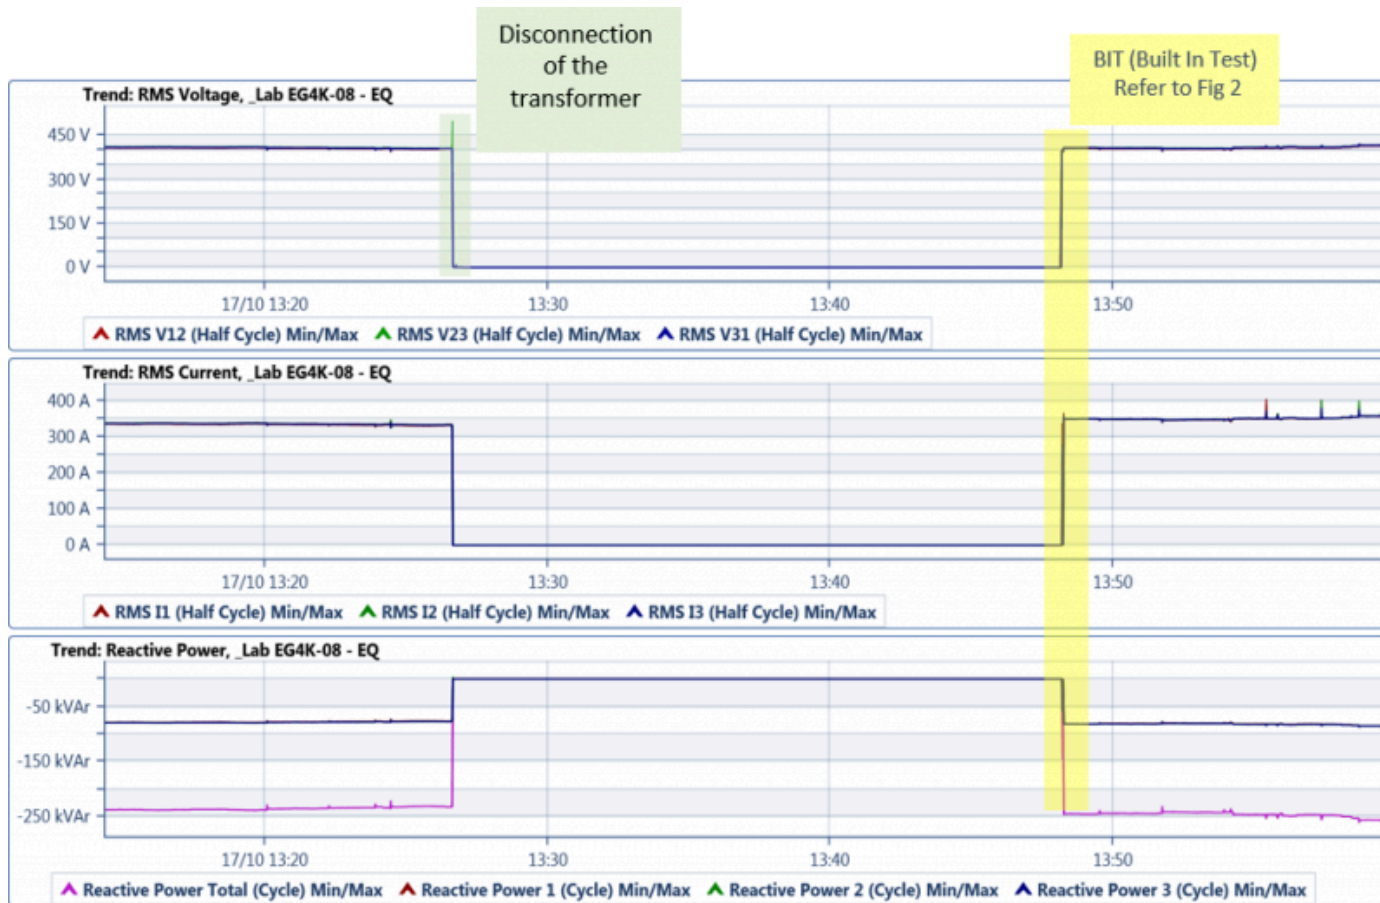
Figure 1: Long time observation on a failure event

In order to trace the source of the failure, The Elspec Black Box (EG4K) was installed on each of the turbines. A few days following installation, the problem was identified as a result of a disconnection of the turbine transformer. During this time, a high spike on the voltage was created, causing a breakthrough of thyristor isolation in the SWM. The failure was discovered later when the turbine was re-energized by switching on the transformer and during the built-in test which is carried out automatically following power up. The problem was solved easily by providing a pre-signal to the Equalizer controller where the controller entered standby mode a few seconds before disconnection from the transformer.

Figure 1 shows the exact timing of the transformer disconnection and the voltage spike which was developed. 20 min later, the transformer disconnected and the BIT (Built in test) was carried out by the Equalizer.

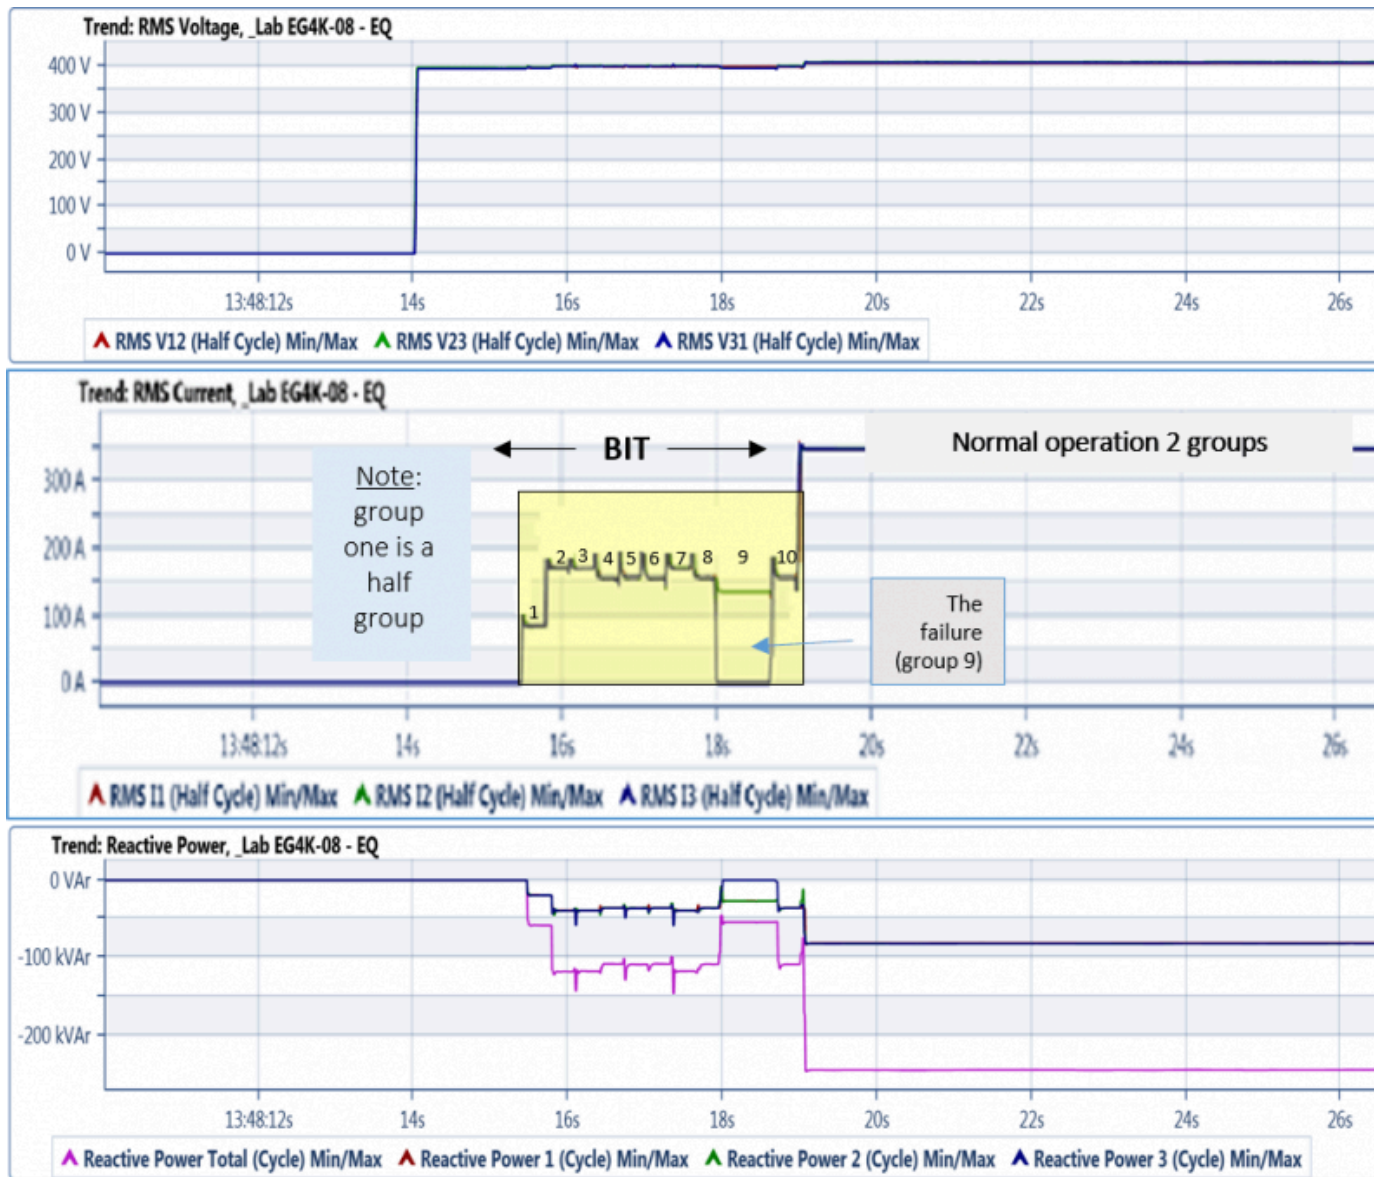
Figure 2: Zoom in on the BIT (Built in test)

Figure 2 shows the BIT (Built in test) in further details. Ten (10) groups were tested, with the first group tested at 60 KVAR and groups 2 through 10 tested at 120 KVAR each. All groups were functioning well excluding group 9, where 1 phase was disconnected and the KVAR was reduced substantially. Upon completion of the test, the equalizer system resumed normal operation where two functional groups were connected and group 9 was disabled (until it could be repaired).

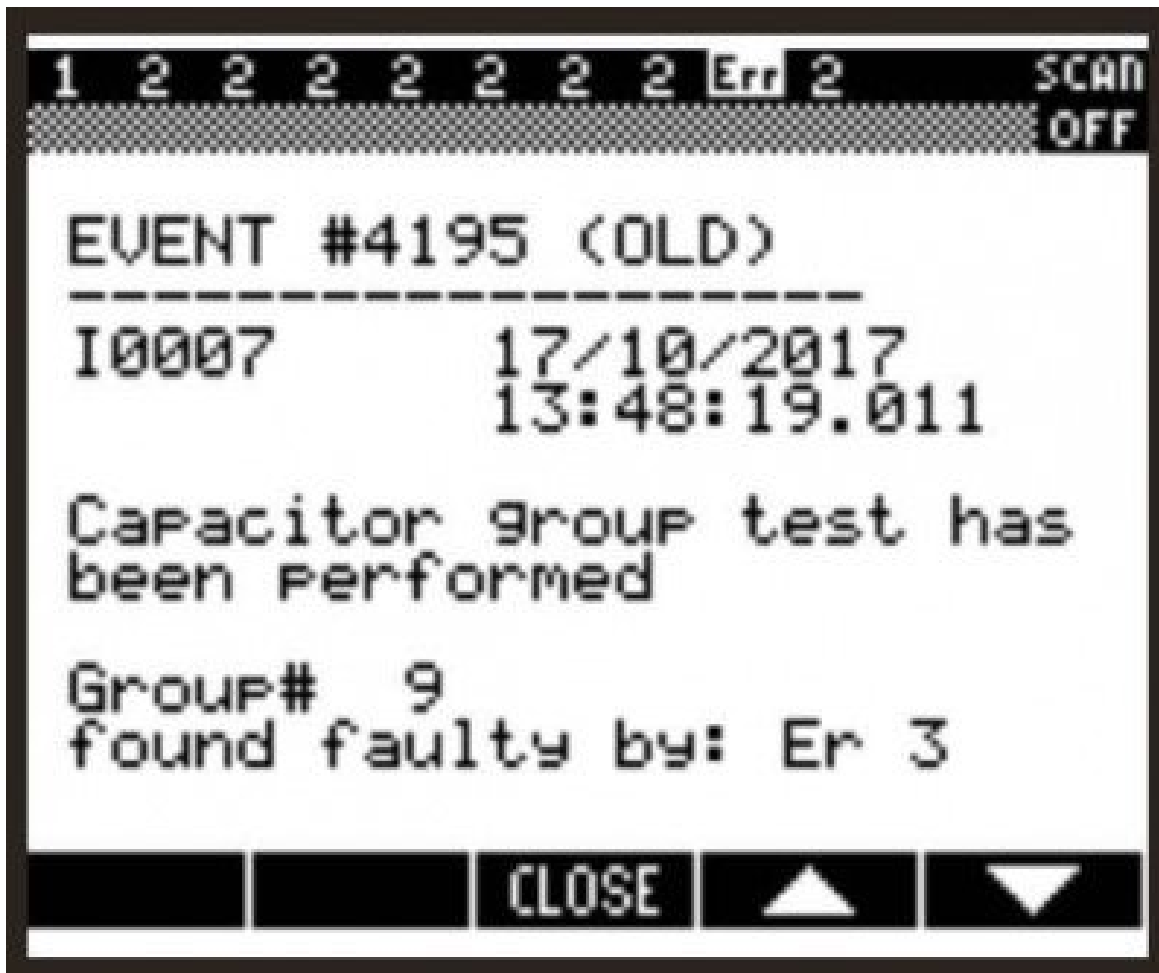
Figure 3: Controller fault screen

In Figure 3 the status of group 9 was reported for the first time as a failure on the failure screen with the exact timing.

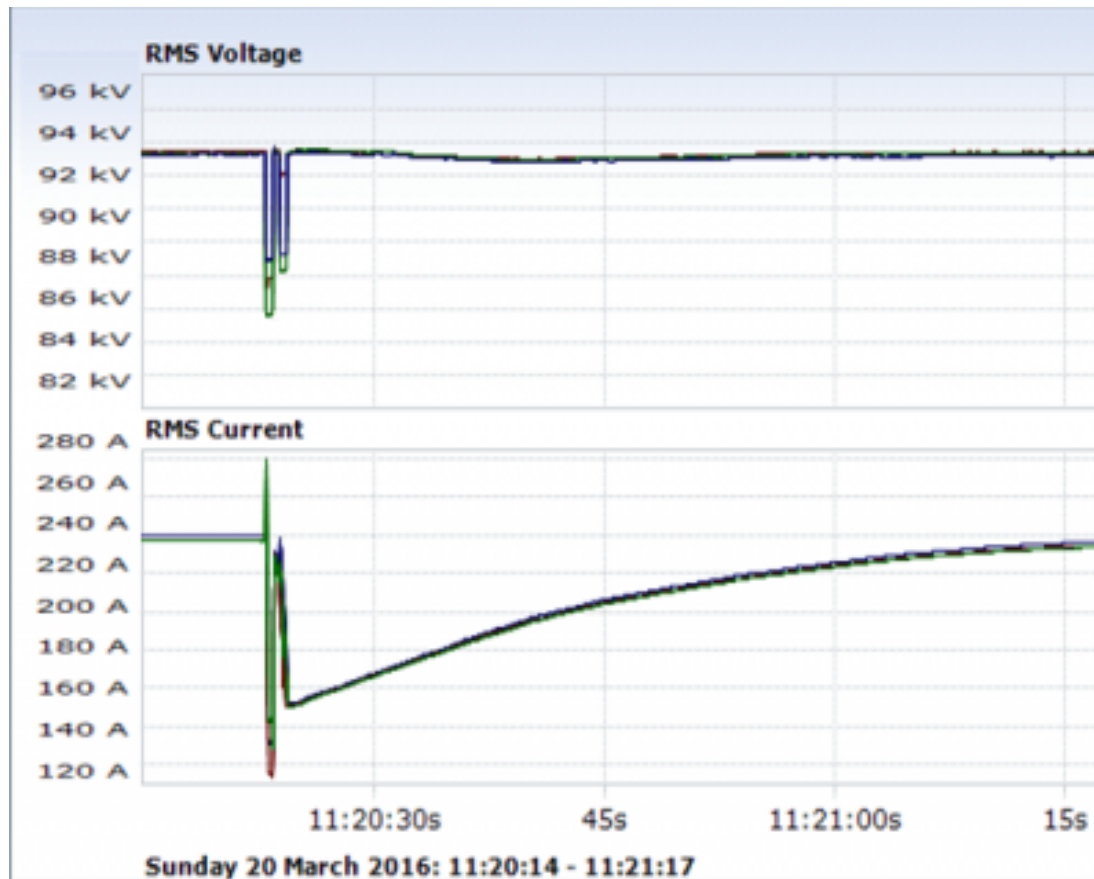
Figure 1: Loss of power event

In the example below, the voltage dropped from 93KV to 86KV – approximately 7%. A traditional **power quality analyzers** with set-up voltage threshold of $\pm 10\%$ did not record the event. In addition the duration of the power loss event was approximately 60 seconds, which was high above the duration of the recorder.

The continuous measurements recorded the event and its full duration, and provided the exact information about the loss of power (60 sec).

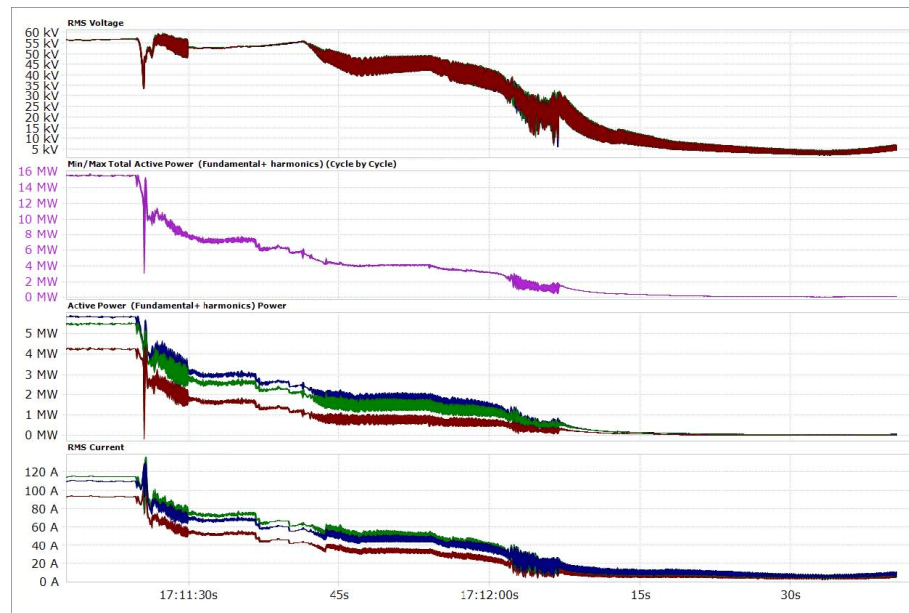
Figure 2: General view of the beginning of the event

The average power of the plant was almost 16 MW. The event started as a short **voltage dip** of approximately 100 msec and then gradually, the voltage dropped within approximately 60 seconds to almost 0. The plant was able to recover after only an hour.

Figure 2 below provides a general view of the first 60 seconds of the event and Figure 3 is a zoom-in of the **voltage dip**.

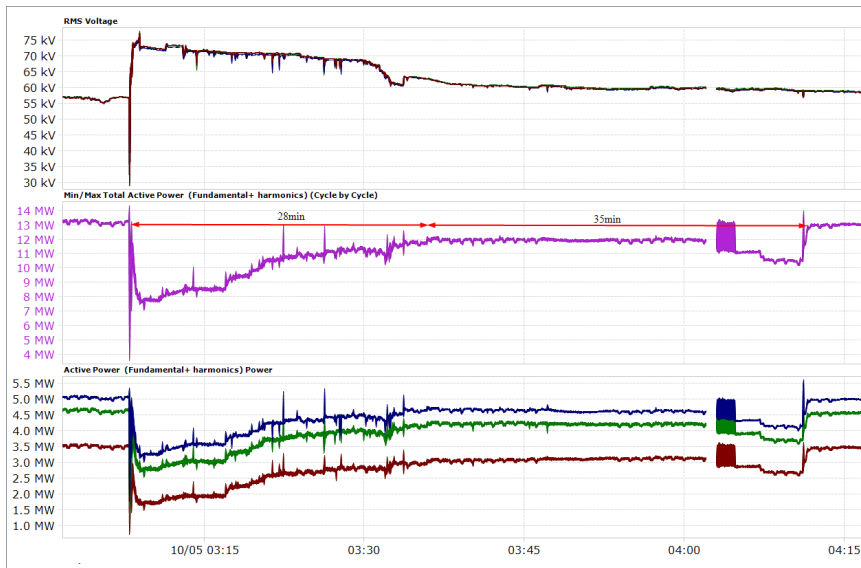
Figure 4: 1 hour continuous recording at 1 cycle resolution

In this case, the voltage oscillated within roughly 5 seconds and then increased to high above the nominal rate. The plant lost most of its power for approximately 10 minutes and only recovered within an hour.

The continuous measurement enabled an in-depth investigation of a long time event in which a full hour elapsed (described in Figure 4) as well as an investigation of the oscillation (refer to the zoom in in Figure 5).
