Case Study

Power Quality Analysis of Transformer Humming Noise

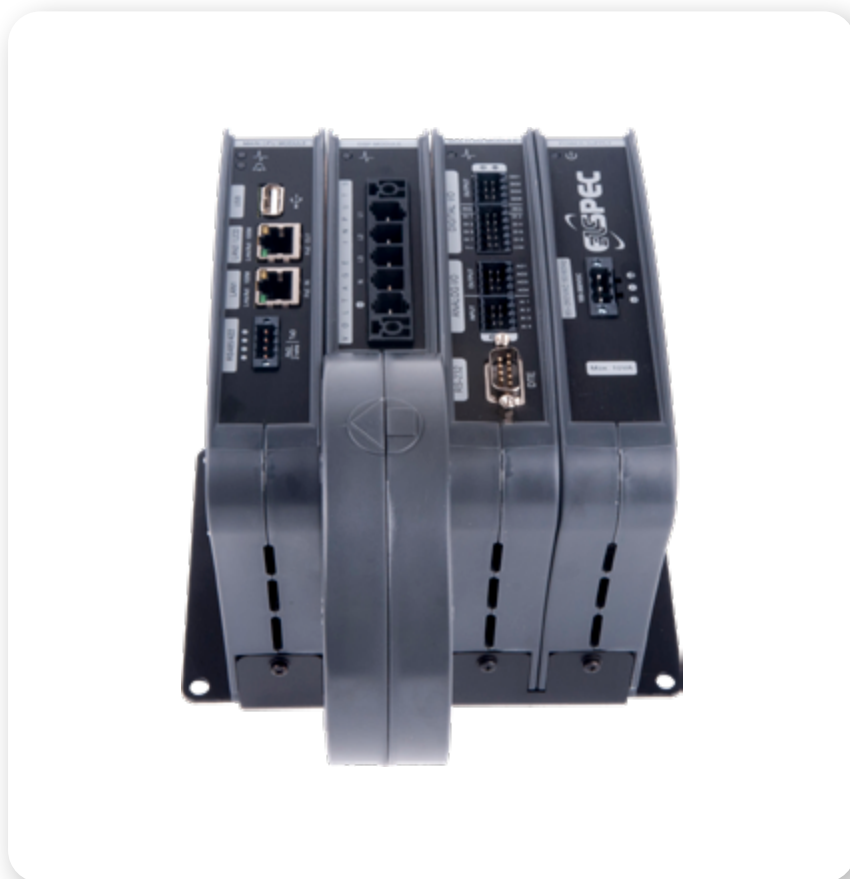
The results revealed a one cycle current impulse at the times of the humming noise. Further investigation indicated that the customer's SVC system was the cause of this inrush current. [SVC systems](#) are crucial for stabilizing the power in industries that work under extremely heavy loads.

Audio recording during the humming sound

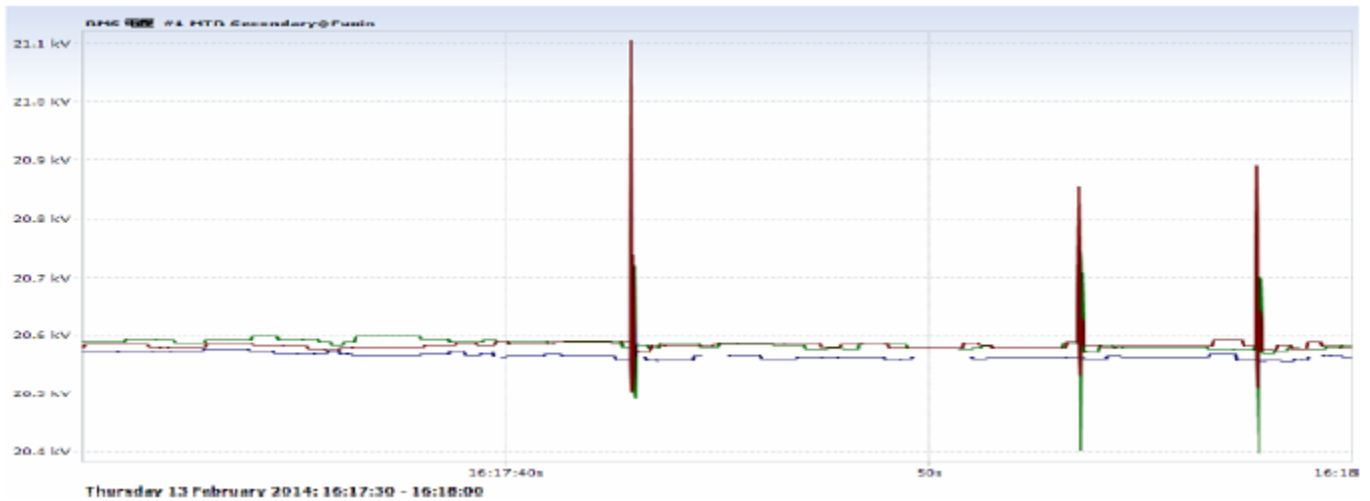
½ cycle RMS values during the audio event above

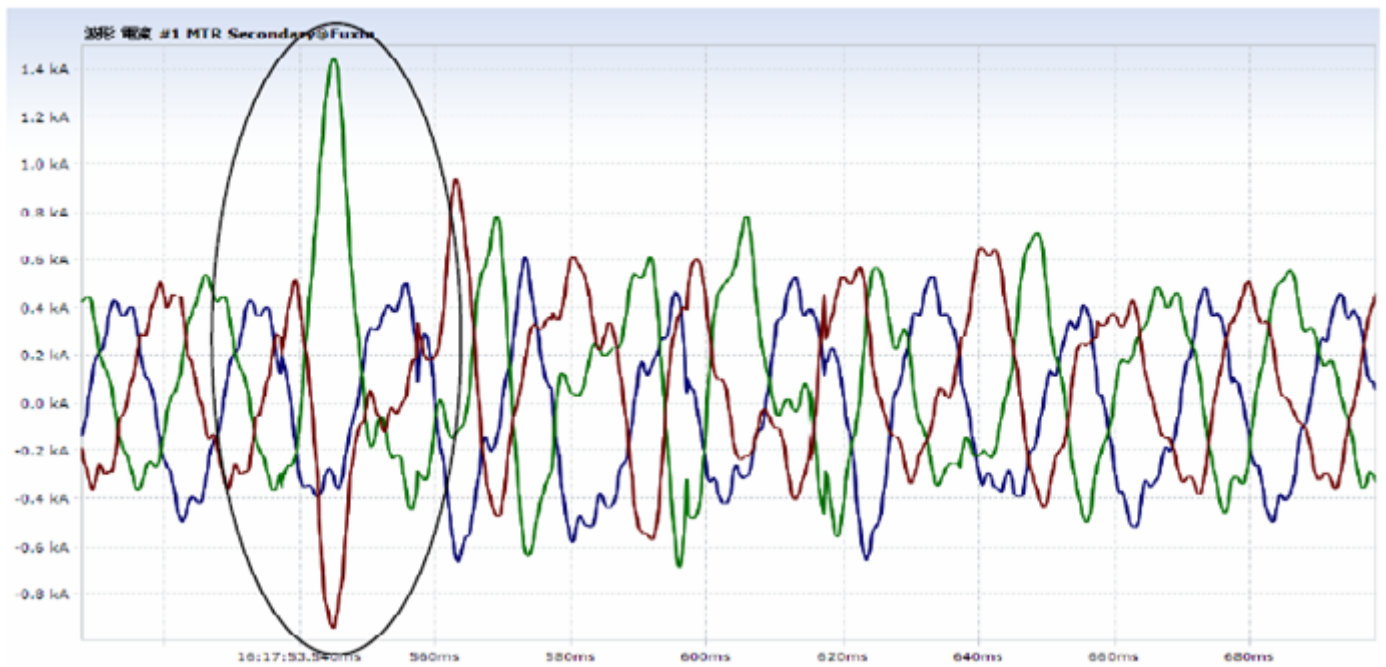
zoom in to the current waveform of the first event above

After the customer SVC system was returned from refinement, additional testing and analysis were performed. No humming noise nor inrush current were detected.
