Case Study

Diagnosing Ground Fault Protection Issues in Data Centers with Elspec's Advanced Power Analysis

Elspec's G4500 Power Quality Analyzer and PQSCADA Sapphire power management software were instrumental in diagnosing and analyzing the root cause of disruptions in data center operations in Brazil, uncovering how the misidentification of faults by the ground leakage protection (GS) system affected overall operations.

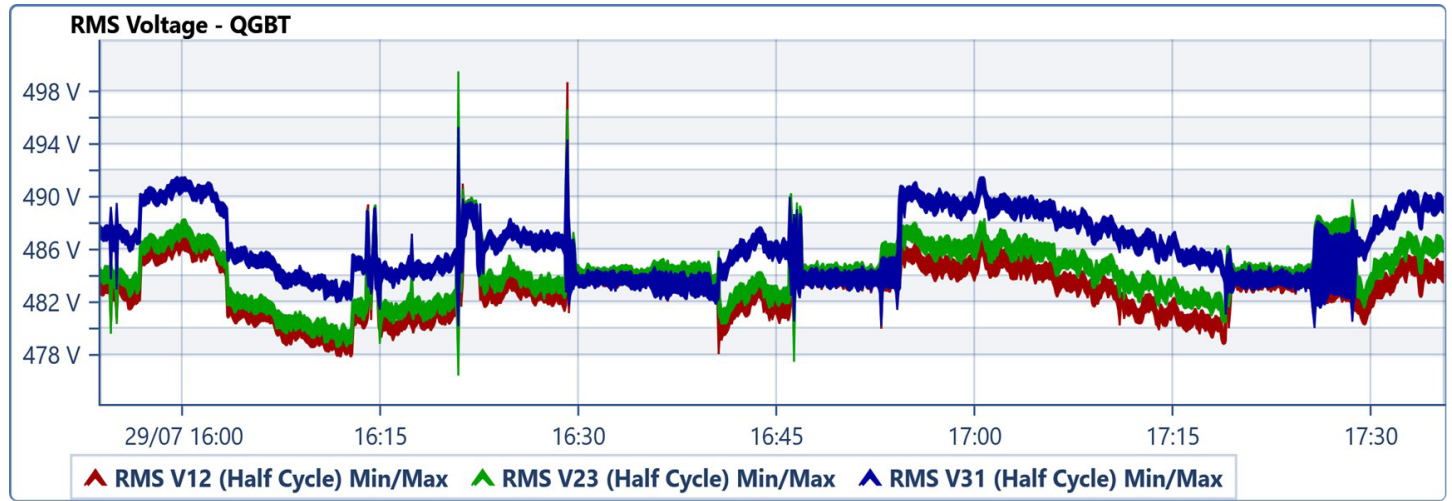
Voltage measurement:

The measurements are synchronized on the following graphics.

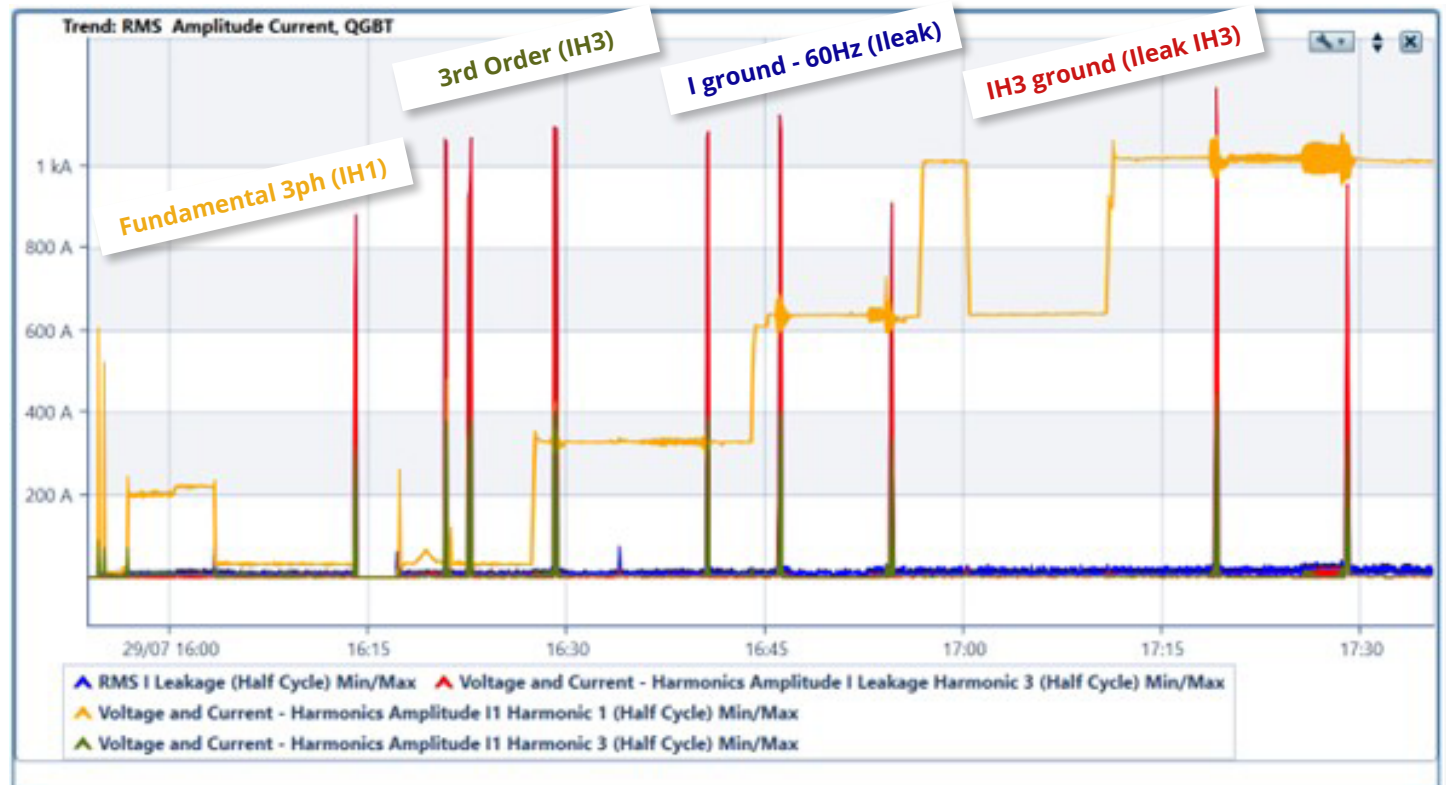
Load Current measurement:

Current with disabled protection
