Case Study

Ensuring Reliable Data Center Commissioning

The importance of Continuous Waveform Recording in Power Quality Monitoring

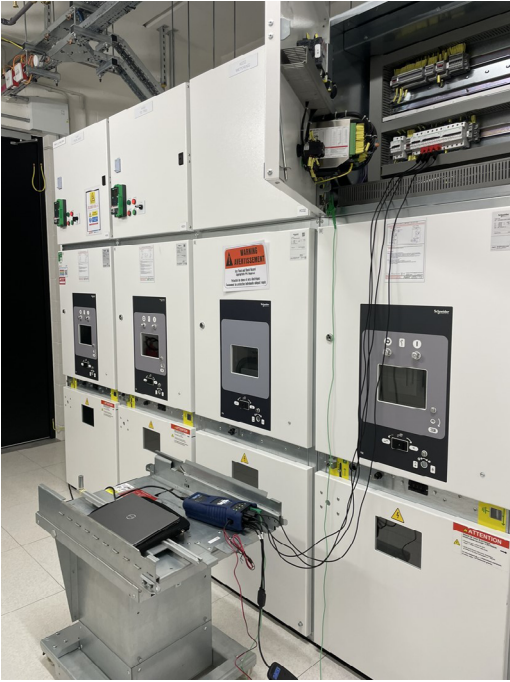
Power Quality Analyzer installed in medium voltage side (upstream B2_MV/LV_Tx)

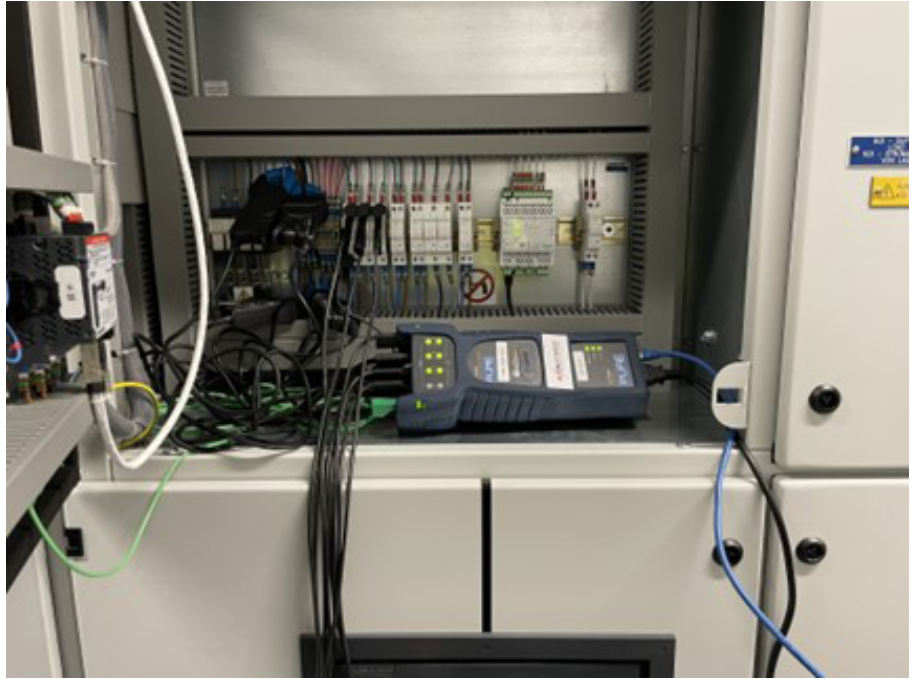
Power Quality Analyzer installed in low voltage side (upstream B1_UPS)

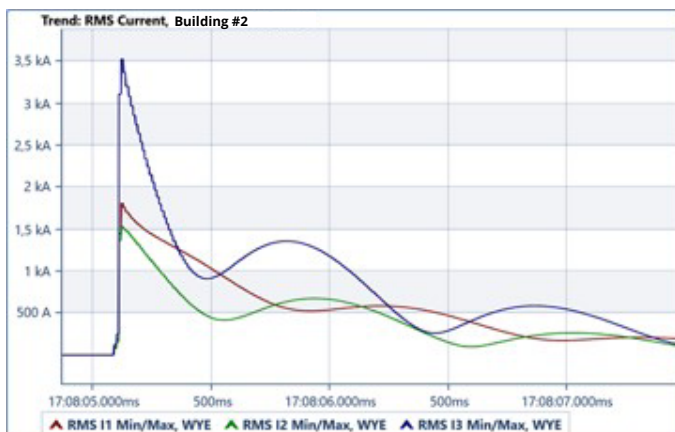
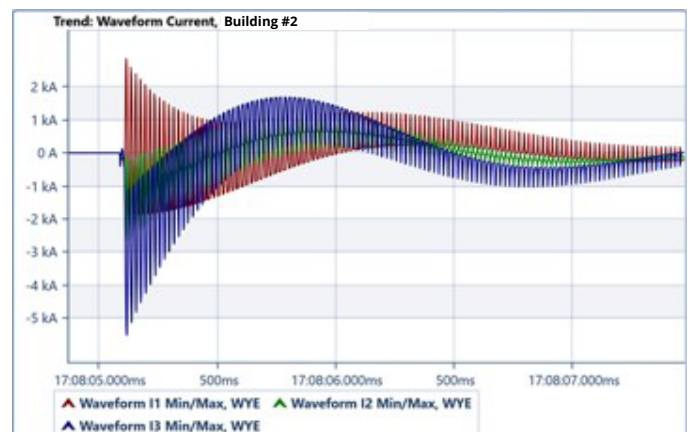
The Building #2 MV transformer energization generated a non-linear inrush current reach in even-order harmonics.

MV side Power Quality recordings – Building #2 MV transformer inrush

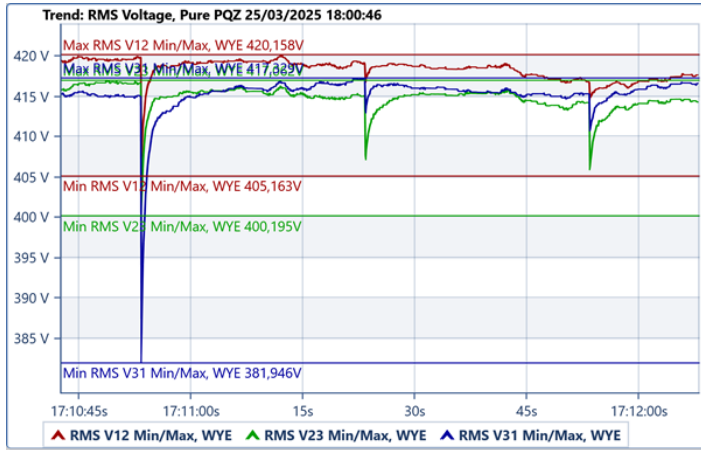
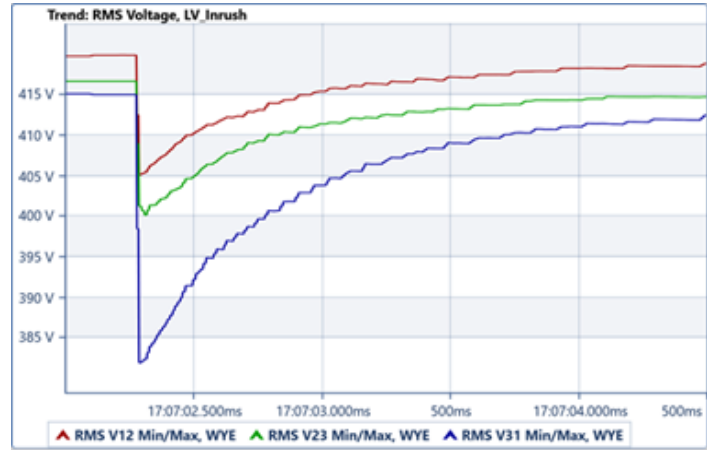
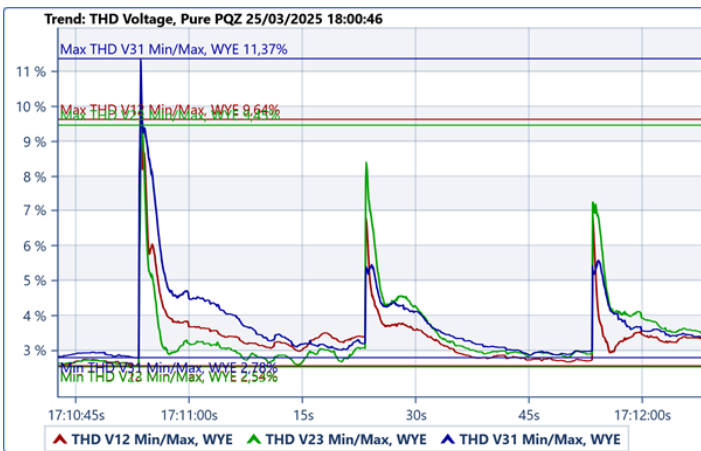
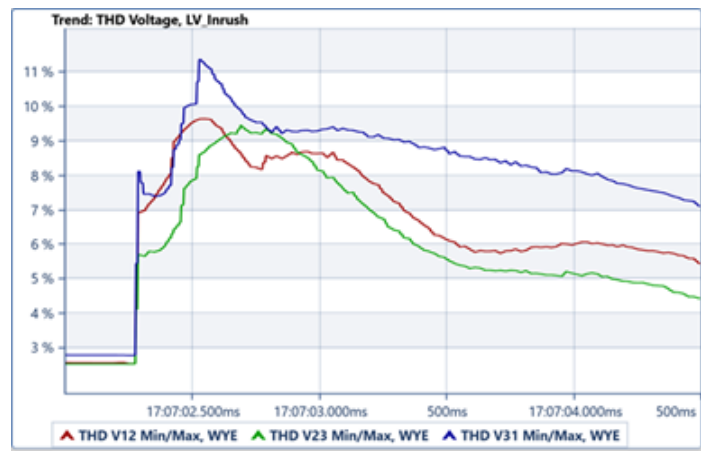
This non-linear current generated during the magnetization of Building #2 transformer caused distortion in the voltage waveform, resulting in instantaneous peaks in the Total Harmonic Distortion of voltage (THDv%) observed in the Building #1 Low voltage installation.

LV side Power Quality recordings – Building #1 UPS upstream

Reviewing the data from the Analyzers on the Building #1 at the same time as the main inrush current spike (17:07:02), revealed voltage drops and THDv spikes.

The maximum THDv% value recorded on Building #1 low voltage installation was out of tolerance range of the UPS systems which were been operating under an “Eco/high-efficiency mode” which is more efficient but more sensitive to voltage distortions.

From this data it appears that the disturbances on Building #2 propagated through the shared HV substation to Building #1, where UPS systems tolerate THDv up to 5%, by generating voltage sags and temporary THDv% spikes due to current non-linearity.

Once this limit was exceeded, the UPSs automatically switched to battery mode, interpreting the event as a power anomaly.

Based on the power quality findings, the engineering team evaluated several technical options to mitigate transformer energization effects and prevent UPS disturbances.
