ADVANTAGES OF USING HIGH RESOLUTION, CONTINUOUS POWER QUALITY RECORDER / ANALYZER IN SOLAR FARMS

OVERVIEW

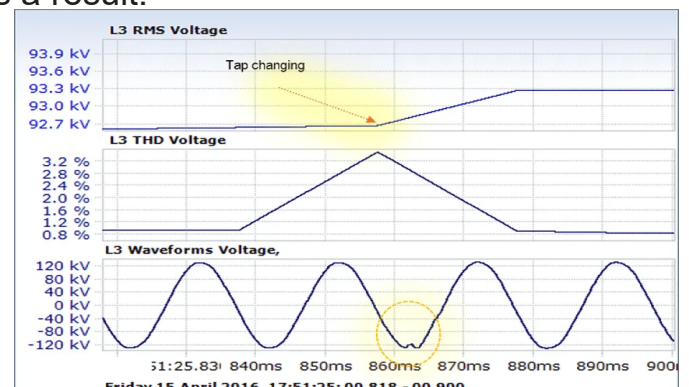
Zoom-in at the first step shows that the voltage was also distorted. This indicates a potential problem in the tap changer. This information triggered maintenance activity to be done, and the tap changer was repaired as a result.

Figure 2: Zoom in on the first change

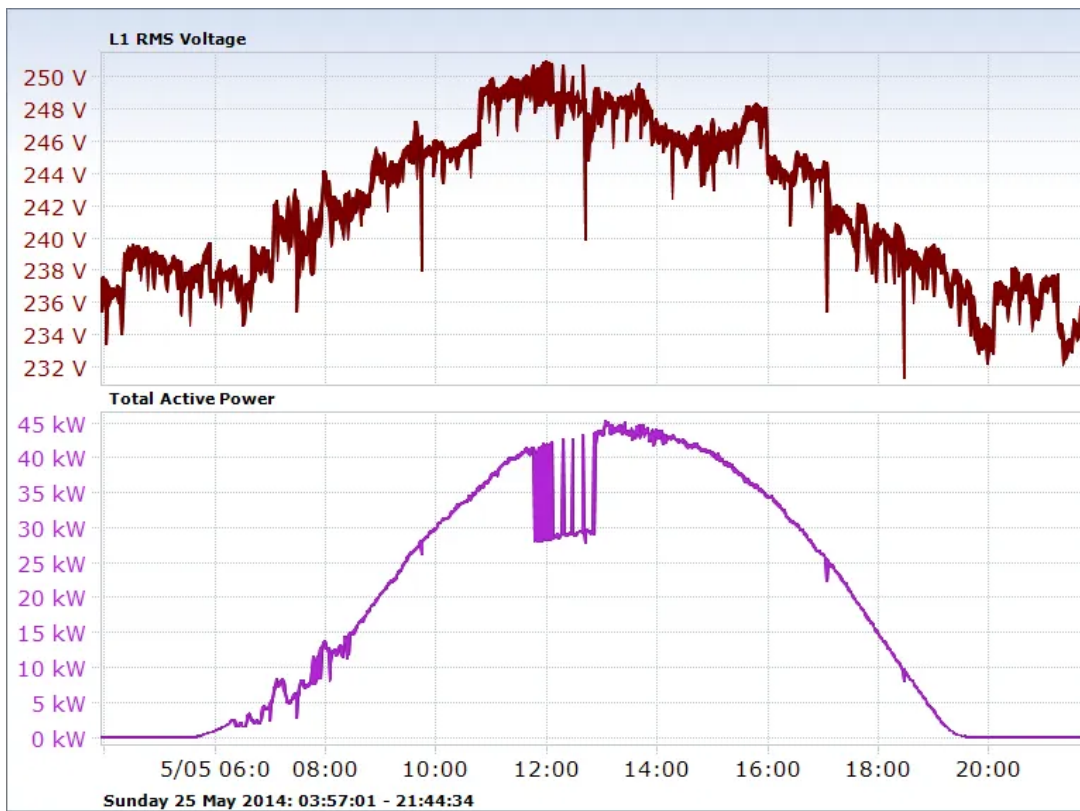
This example illustrates the effect of the generated power (KW) on the voltage level in a 50KW photo-voltaic system connected to a LV network. Daily fluctuations of power

Figure 4: daily changes of power

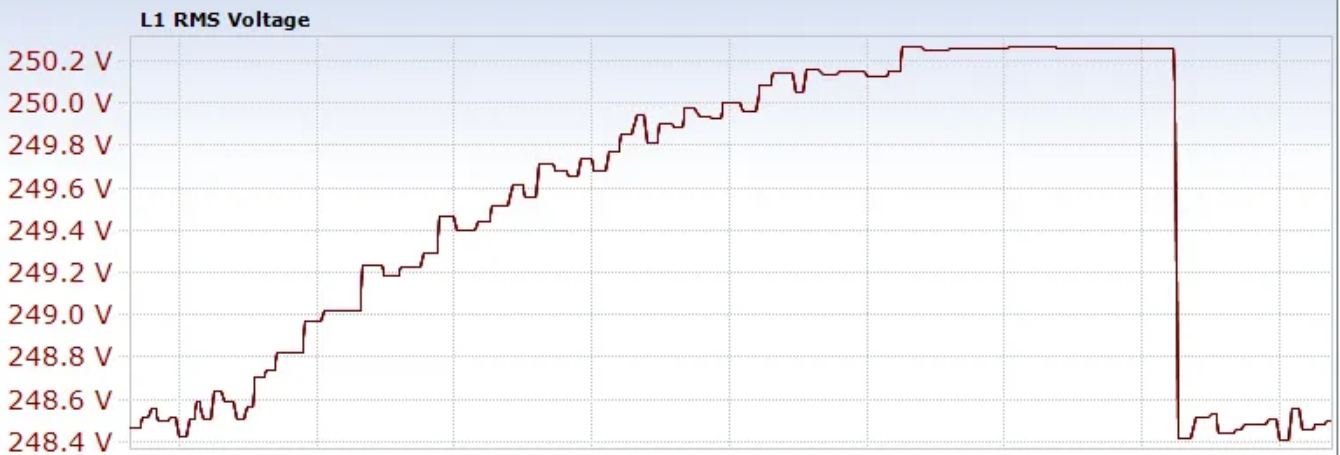
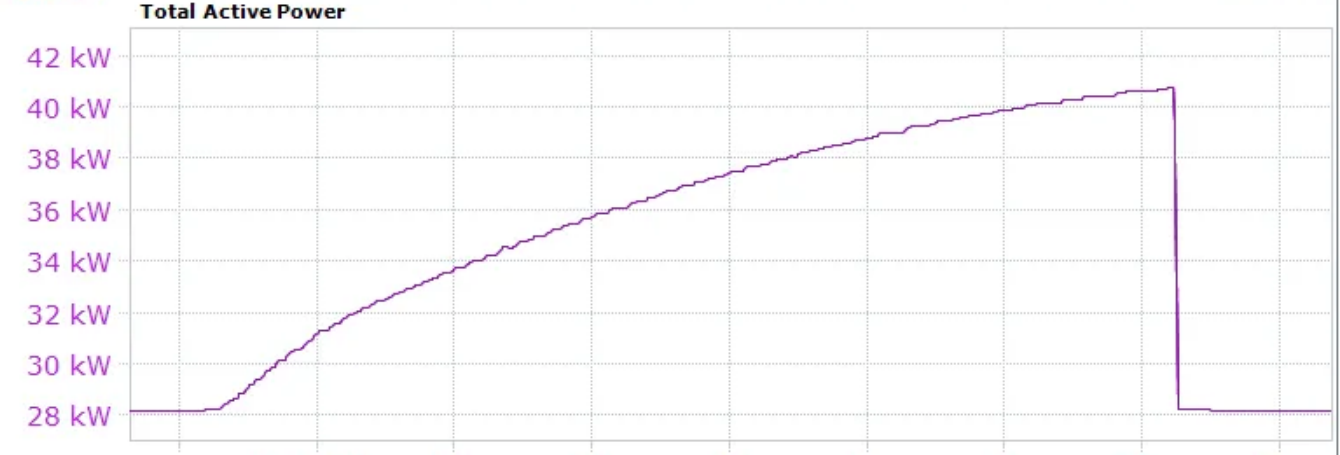
Sunday 25 May 2014: 11:47:08 - 11:47:17

we zoomed in to 9 seconds window as shown in the following Figure – 6. The shape of voltage and power raise is caused by a malfunctioning of the photo-voltaic system that causes unnecessary voltage changes.
