## Case Study

# Identifying the Cause of Laser Cutting Interruptions in Automotive Manufacturing with Power Quality Analysis

Elspec's power quality analyzers identified the root cause of laser cutting machine interruptions in automotive manufacturing in Macedonia, enabling a targeted solution that enhanced operational stability.

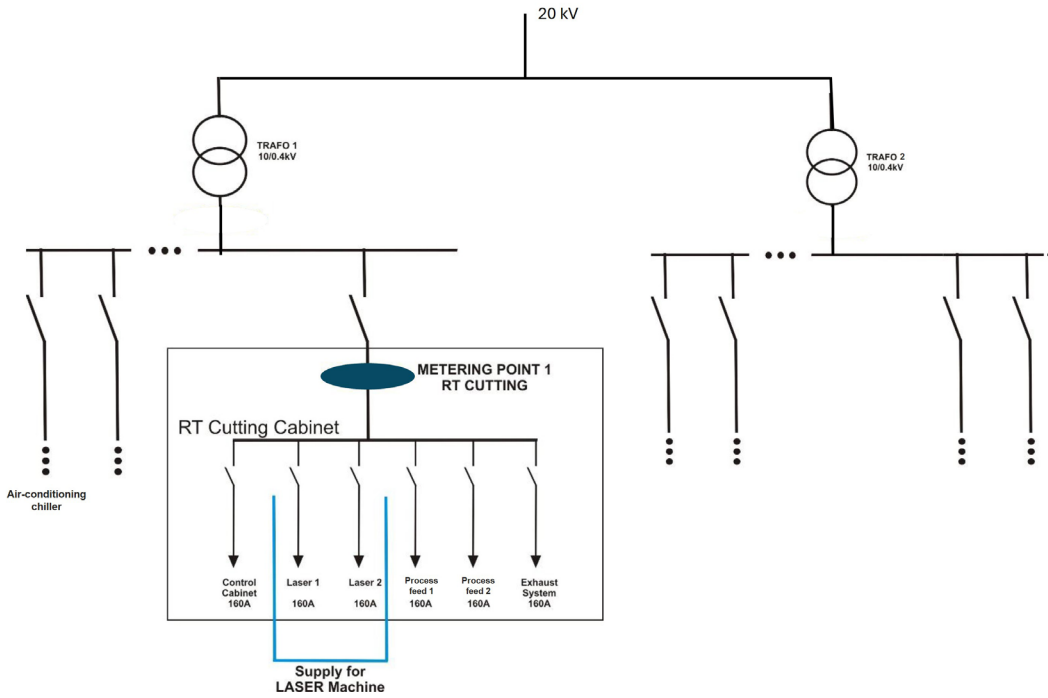
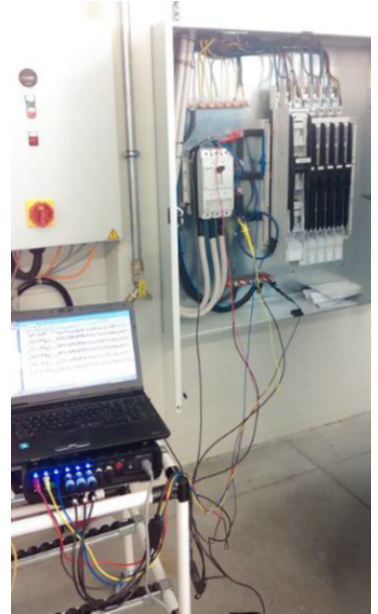
Single pole scheme – Supplying the LASER Machine

The G4500 analyzer's high sampling rate of 1,024 samples per cycle enabled the monitoring of rapid voltage fluctuations, enabling the detection of voltage events lasting as little as 19 microseconds—critical for understanding disturbances in a sensitive system like the laser cutting machine. The illustration below shows that first, an analyzer was connected on the METERING POINT 1.

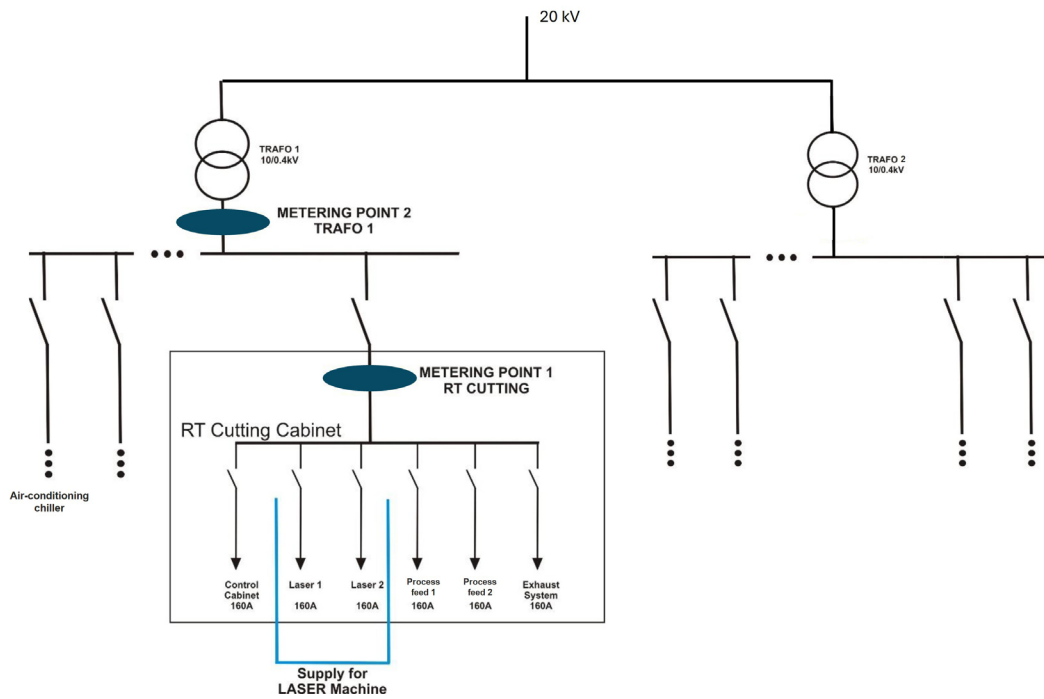
Single pole scheme – adding a 2<sup>nd</sup> analyzer

This led Logging Electronics to decide to connect a second G4500 analyzer to the PCC (The point of common coupling) on Transformer 1 main distribution point.

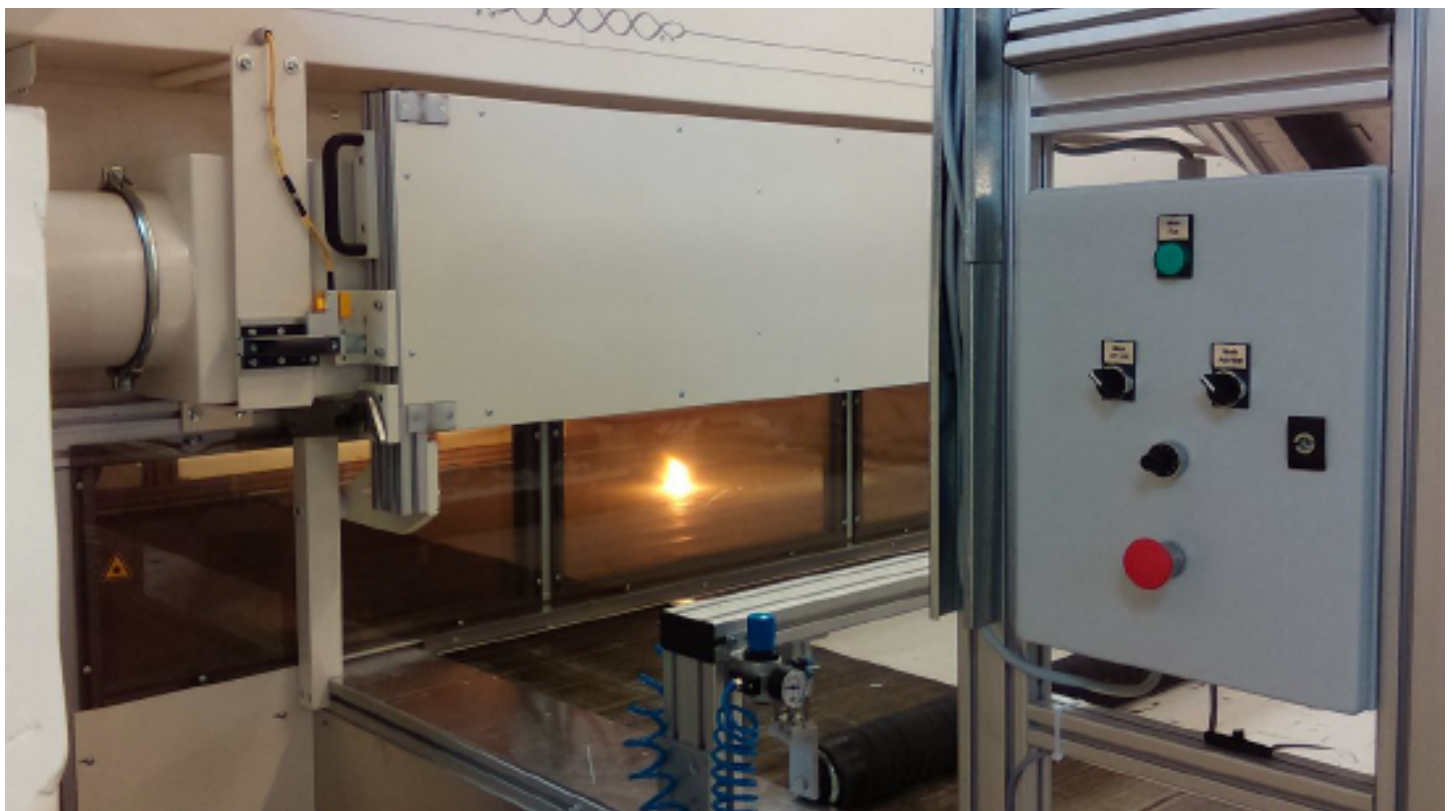
Data from 2nd analyzer showed Rapid Voltage Changes (RVCs) occur approximately every 4-5 minutes. These fluctuations are likely caused by a load connected to the transformer. However, during the period of recording, the laser cutting machine continued to operate without any issues. Specifically, there were three instances where both lasers were operating simultaneously—at 14:18h, 14:40h, and 15:10h. Despite the presence of the RVCs, the machine continued its cutting cycles without any forced shutdowns.
